# Geological Hazards

Revised, 2nd Edition

Earthquakes – Tsunamis – Volcanoes  
Avalanches – Landslides – Floods

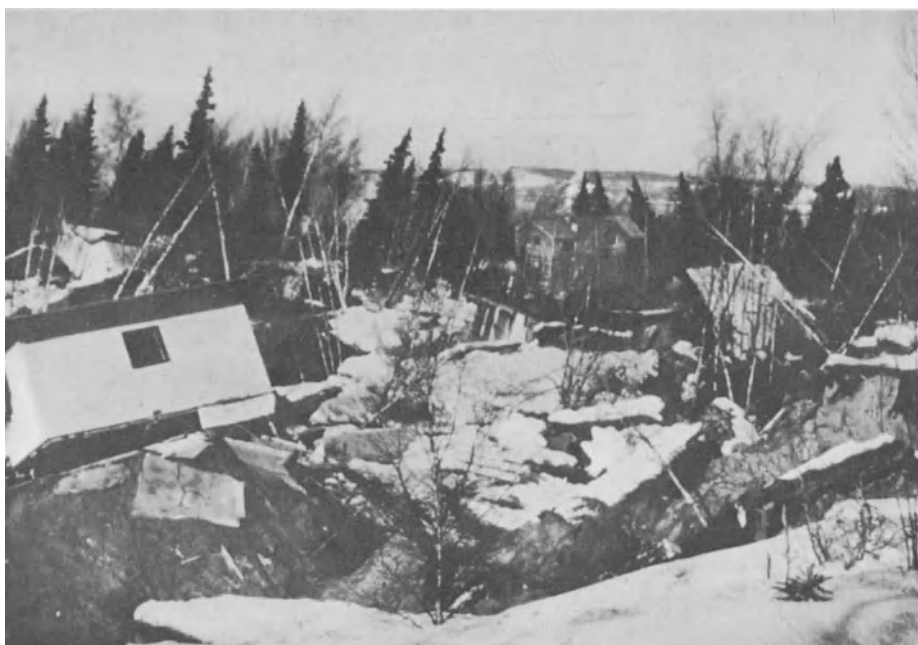
Plate 1.1. View of damaged houses due to great slide at Turnagain in 1964 Alaskan earthquake. Soft clay bluffs about 22 m high failed in the shaking. The slide extended 2,800 m along the coast-line and regressed inland 300 m. (Courtesy of USGS)

The post-earthquake appearance of the landscape at Turnagain Heights so graphically described by Mr. Atwood is shown in Plate 1.1. The extreme damage was a direct result of the failure of the clay soil during the ground shaking. This led to a massive landslide down toward the sea (see Chapter 4).

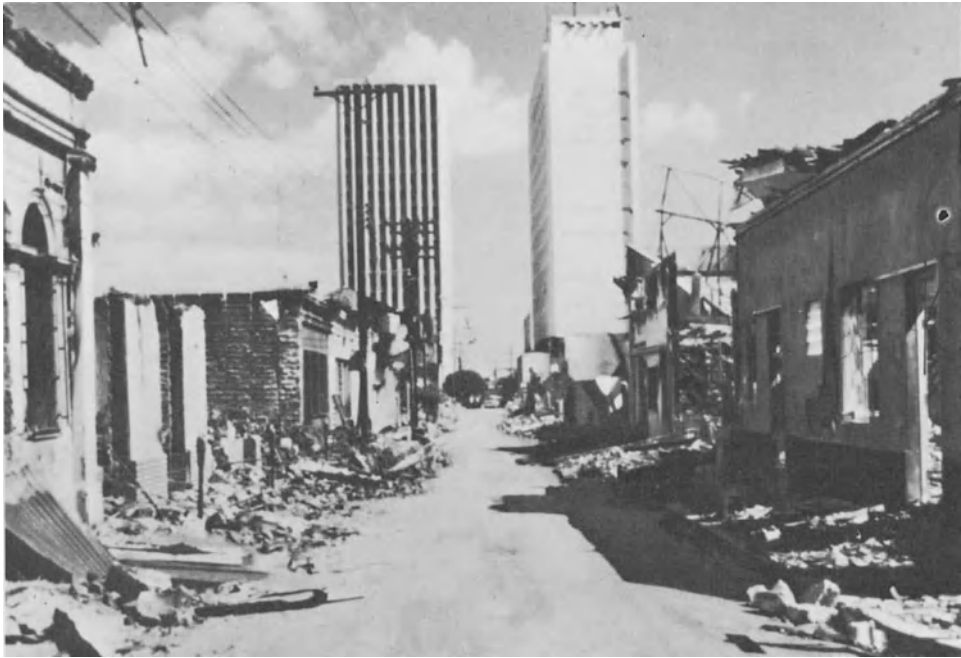
Plate 1.2. The great variation in damage in the Managua 1972 earthquake. The torquezal dwellings (space between vertical wood studs is a “pocket”, packed with mud and stone) collapsed (high intensity rating?) but the modern Banco de America building in the background stood with no substantial structural damage (low intensity rating?). (Courtesy of M. Sozen)

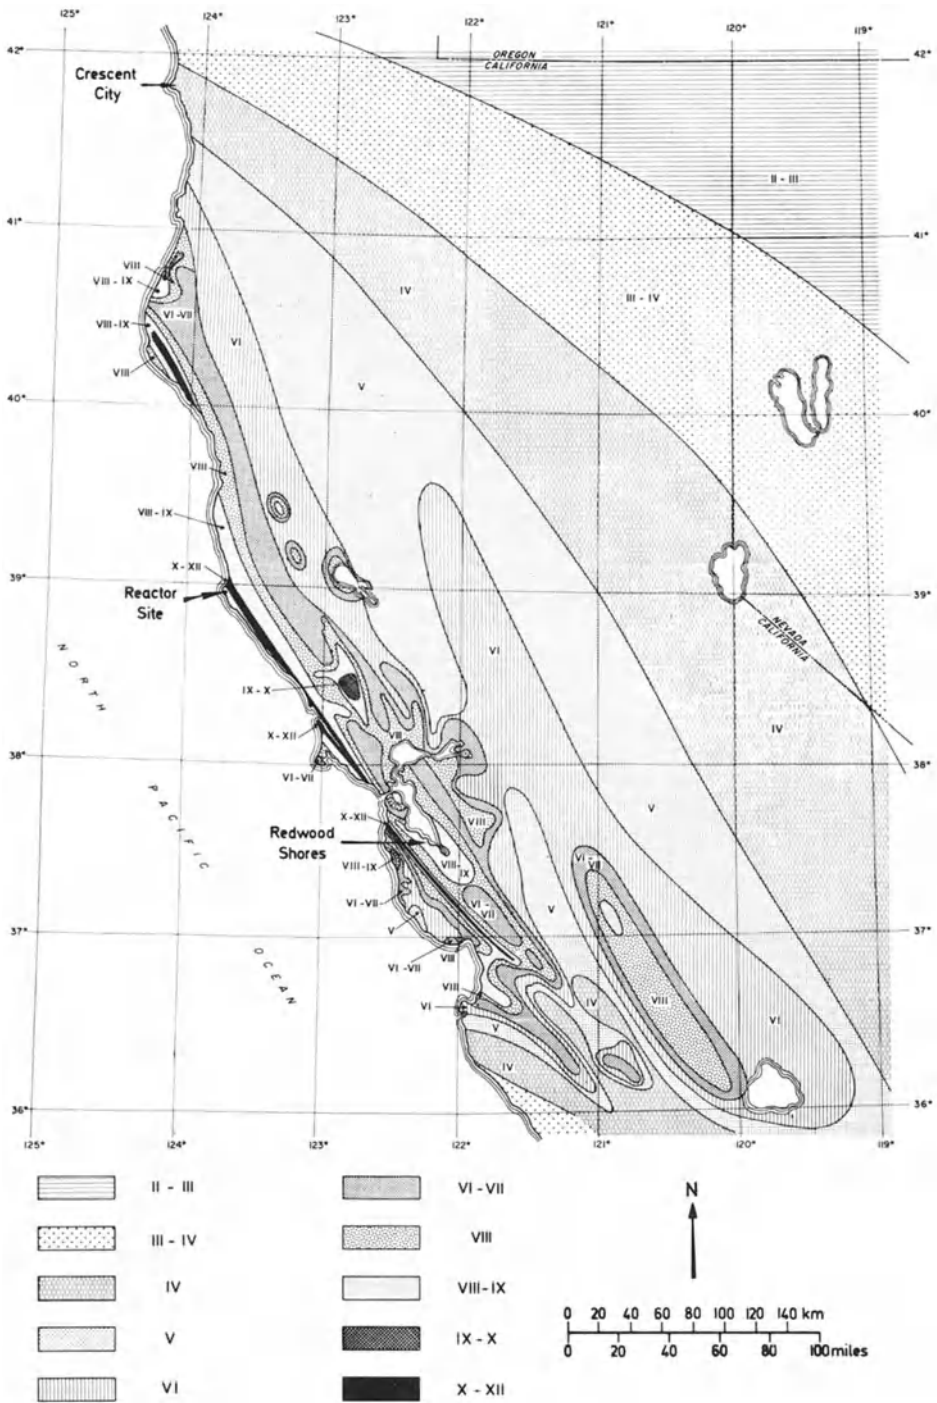
Fig. 1.3. Isoseismals for the great 1906 California earthquake. The contours separate areas of equal intensity of shaking as rated on the Modified Mercalli (MM) scale. (After the Report of the State Earthquake Commission, 1908)

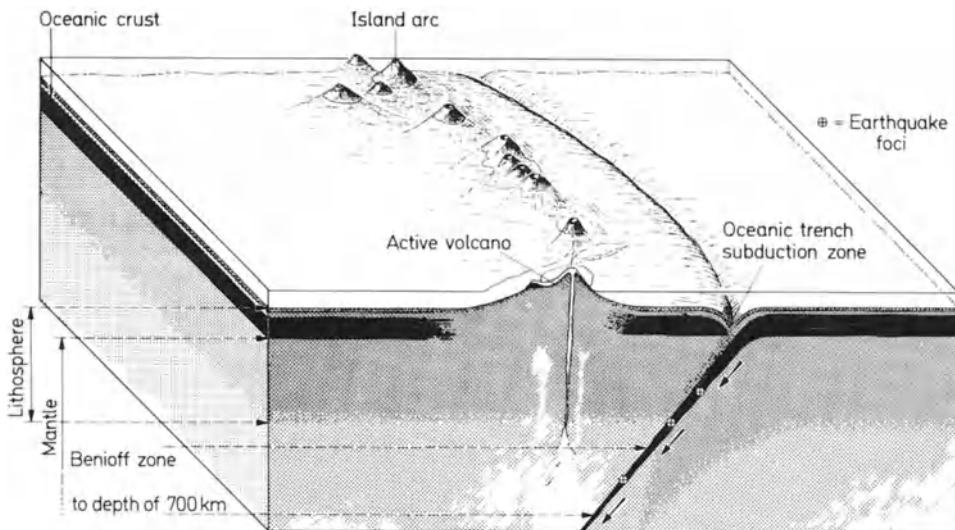
Fig. 1.4. Model of a lithospheric plate and *Benioff zone* moving down beneath an island arc. The less dense magma rises upwards and erupts as lava on the ocean floor where it builds an island arc

Geological and seismological studies made after the earthquake have led to a model which explains most of the observed vertical and horizontal motions and extent of the shaking. This model requires the thrusting southward of Alaska at a shallow angle of perhaps 20° over a fracture lying along the submarine trench (see Fig. 1.4 for a generalized picture).

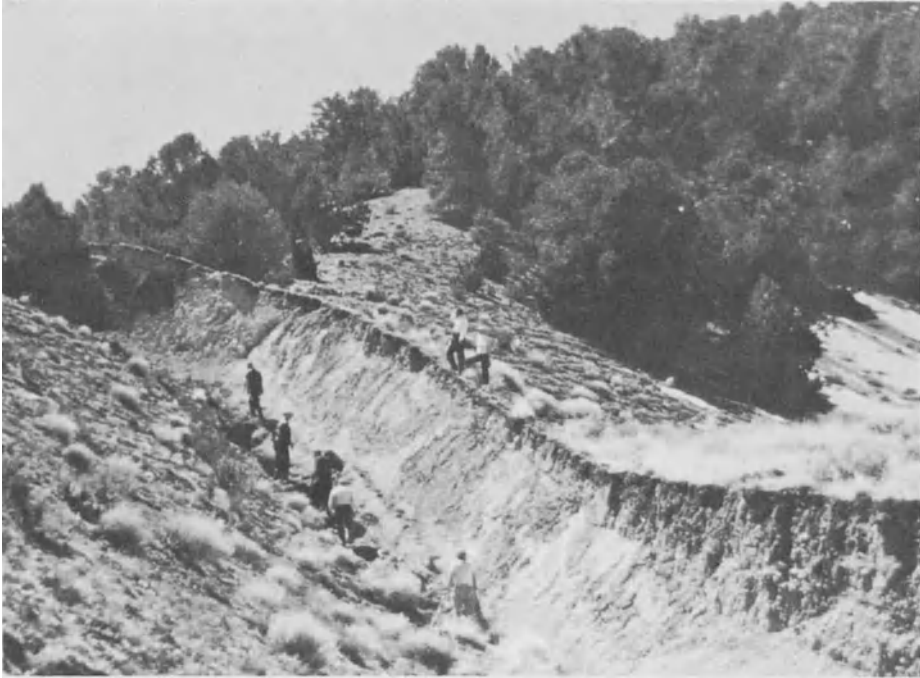
Plate 1.3. Normal fault scarp (4.5 m) associated with the Dixie Valley-Fairview Peak earthquake (Nevada) of December 1954. (Courtesy of P. Byerly)

large vertical motions occur, such as were evident in the 1954 Dixie Valley, Nevada earthquake (Plate 1.3) and in California in the 1971 San Fernando earthquake, where an elevation change of three meters occurred across the fault in some places.

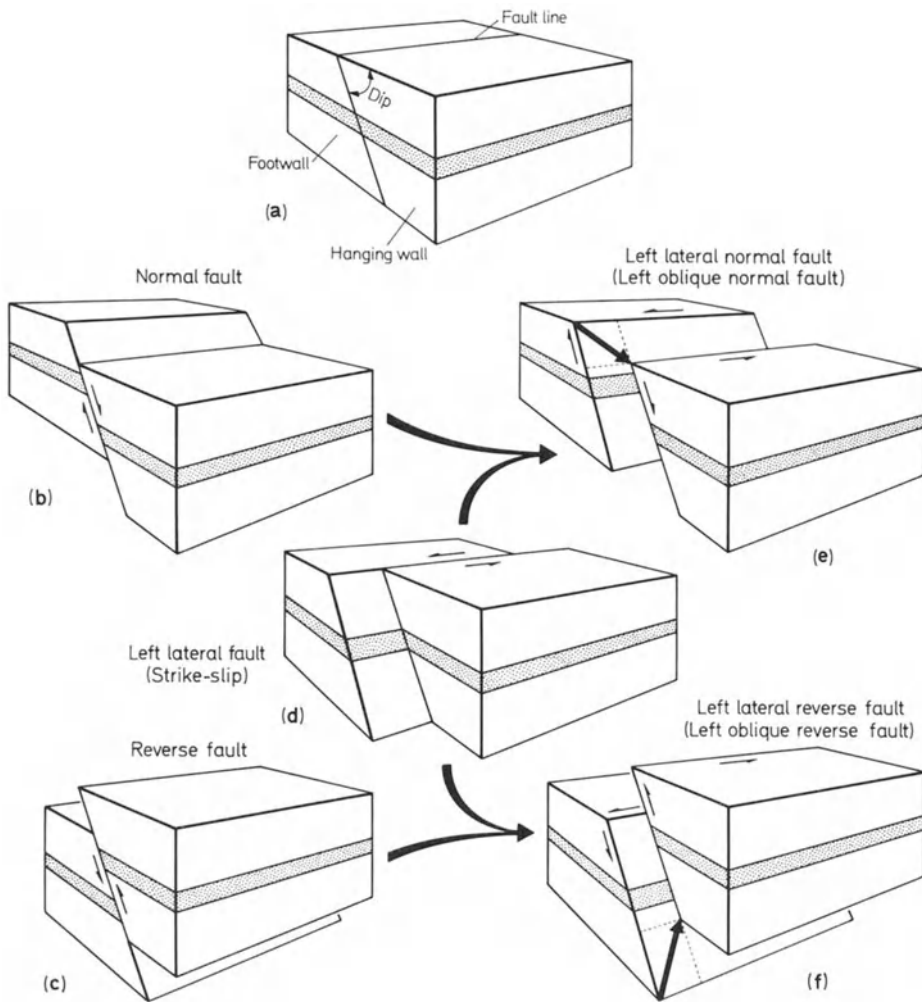
Fig. 1.7a-f. Diagrammatic sketches of fault types (a) names of components, (b) normal fault, (c) reverse fault, (d) left-lateral strike-slip fault, (e) left-lateral normal fault, (f) left-lateral reverse fault. (After California Geology, November 1971)

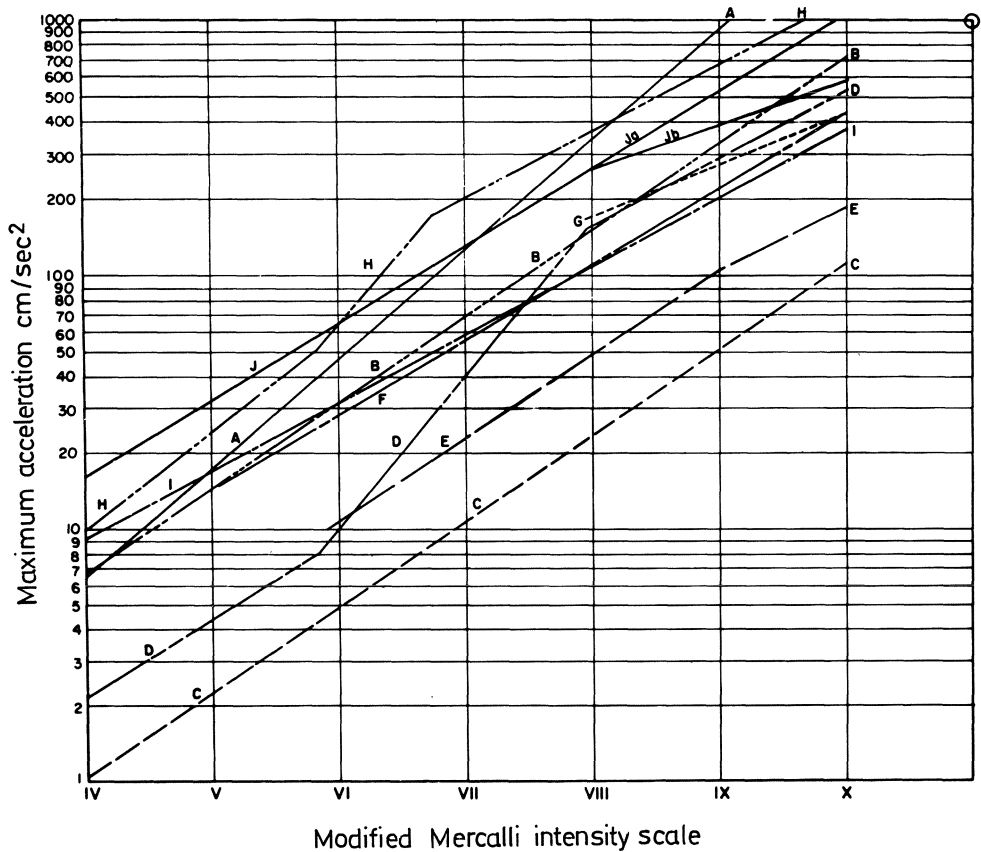
Fig. 1.8. Some empirical correlations of MM intensity with peak ground acceleration measured in earthquakes. *A* Hershberger; *B* Gutenberg-Richter (1942); *C* Cancani (1904); *D* Ishimoto (1932); *E* Savarensky-Kirnos (1955); *F* Medvedev et al. (1963); *G* N.Z. Draft By-Law; *H* Kawasumi (1951); *I* Cornwell; *J* Neumann (1954). *O* San Fernando earthquake, Feb. 1971

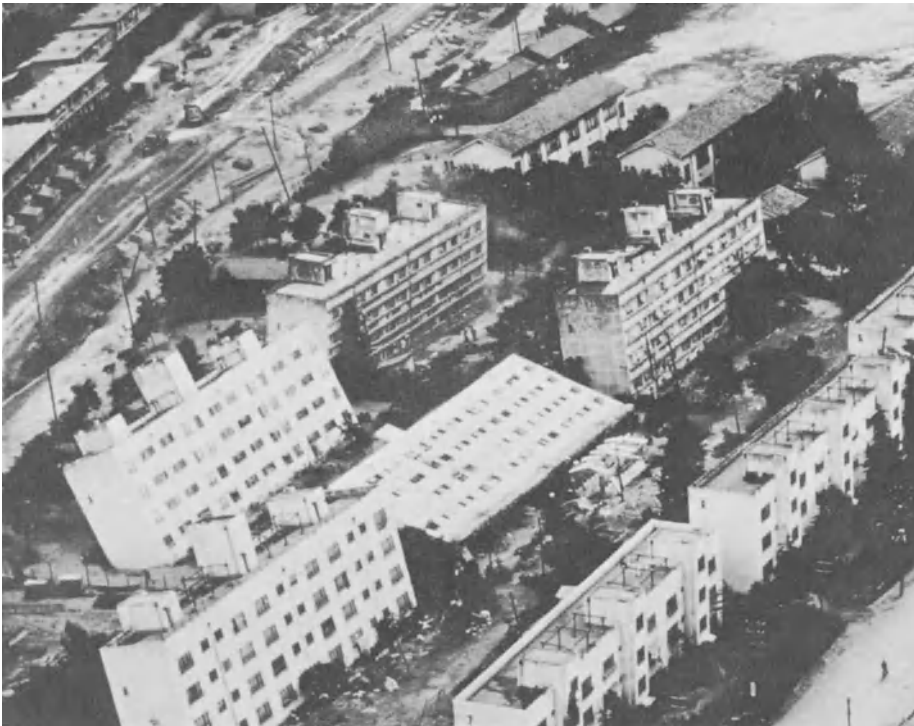
Plate 1.4. Liquefaction of saturated sands led to tilting of apartment buildings in Niigata in 1964 earthquake. (Courtesy of T. Mikumo)

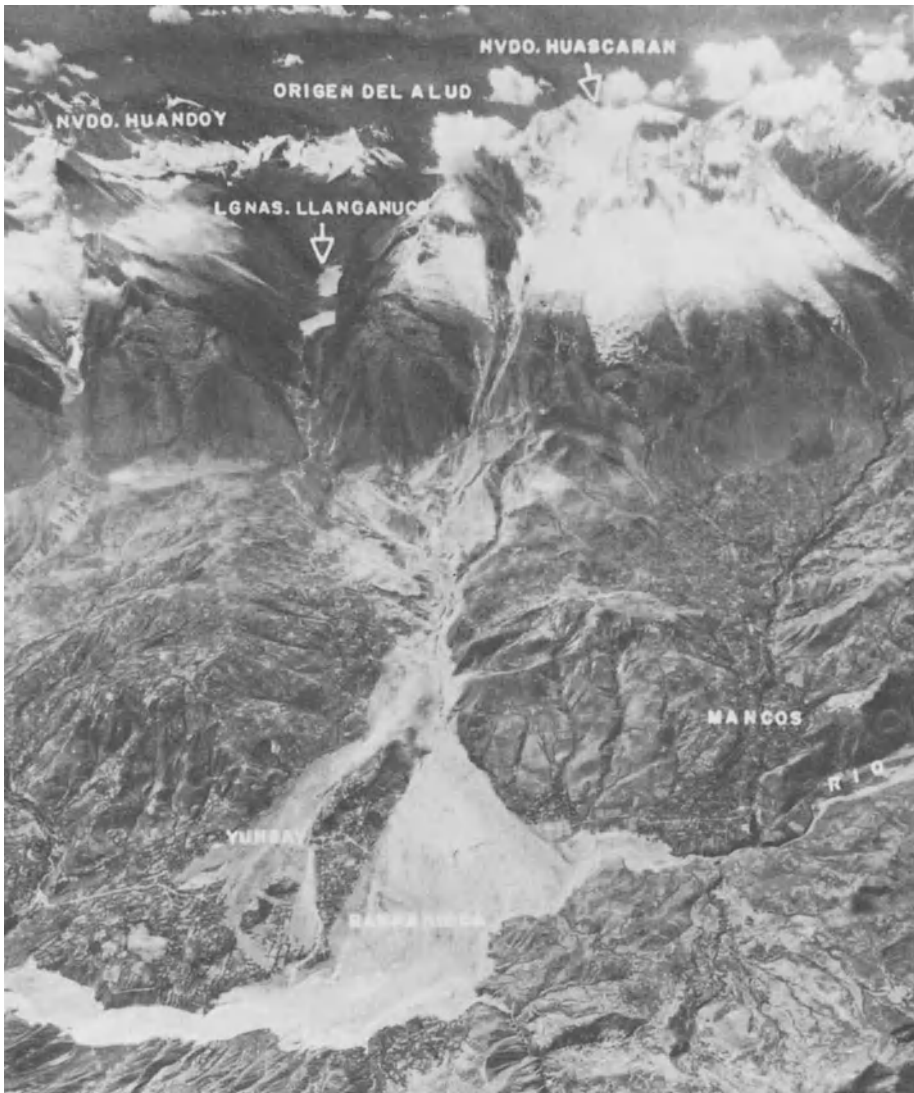
Plate 1.5. Aerial view of Mt. Huascarán and the debris avalanche that destroyed Yungay and Ranrahirca in the May 1970 Peru earthquake. (Courtesy of Servicio Aerofotografico Nacional de Peru and L. Cluff)

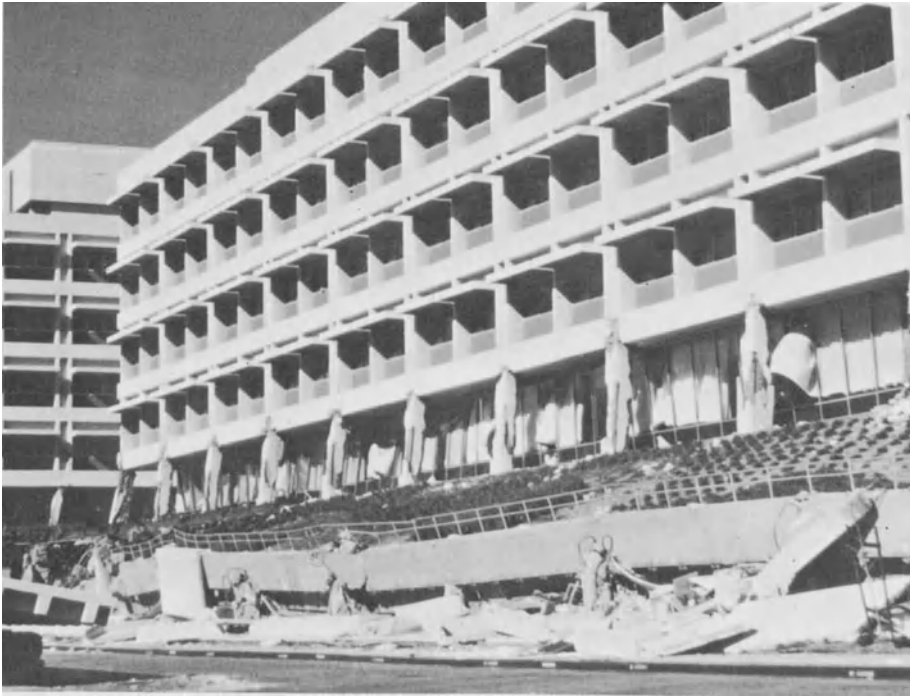
Plate 1.6. Damage to reinforced concrete columns at the new Olive View hospital in the 9 February 1971 California earthquake. (Photo by B.A. Bolt)

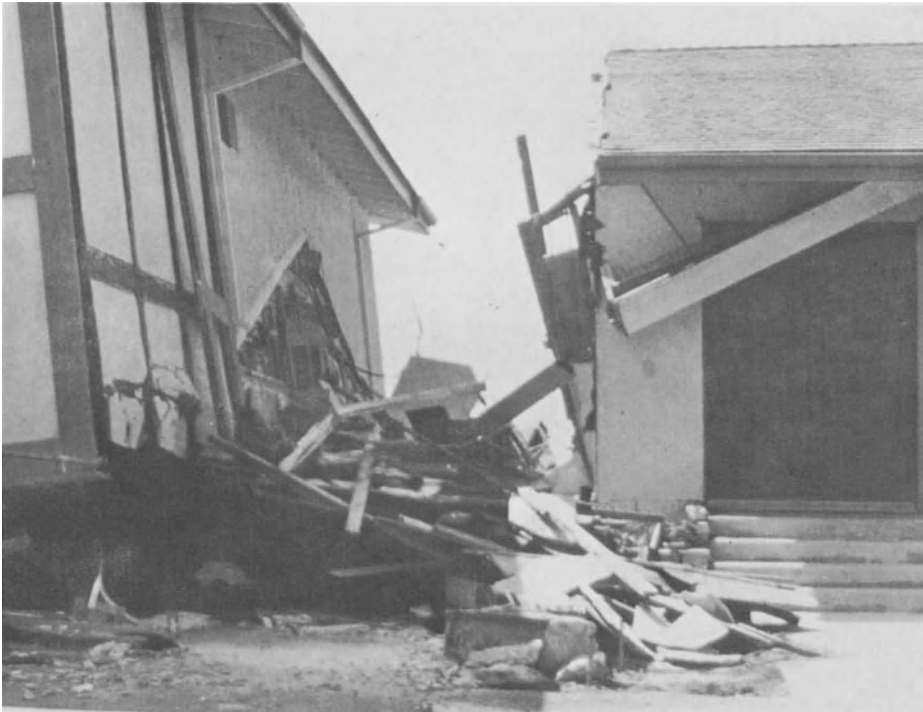
Plate 1.7. Two-story wing of a new split-level house collapsed in the 1971 San Fernando earthquake crushing the automobile parked in the ground-level garage. The garage construction used reduces the lateral bracing. (Photo by B.A. Bolt)

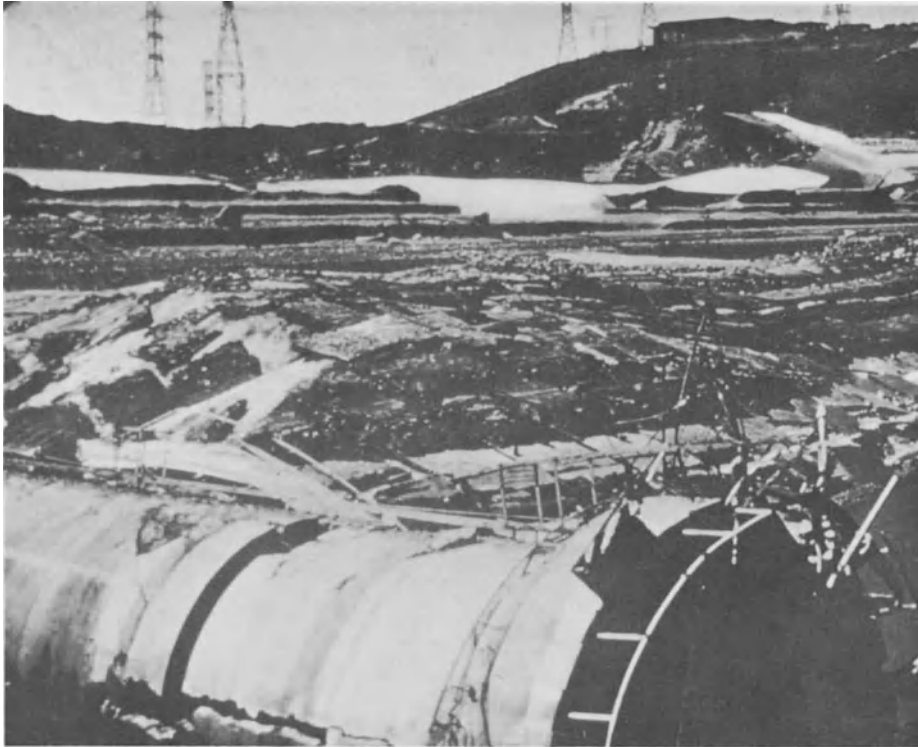
Plate 1.8. Slumping of Van Norman dam in the 9 February 1971 California earthquake. (Photo by B.A. Bolt)

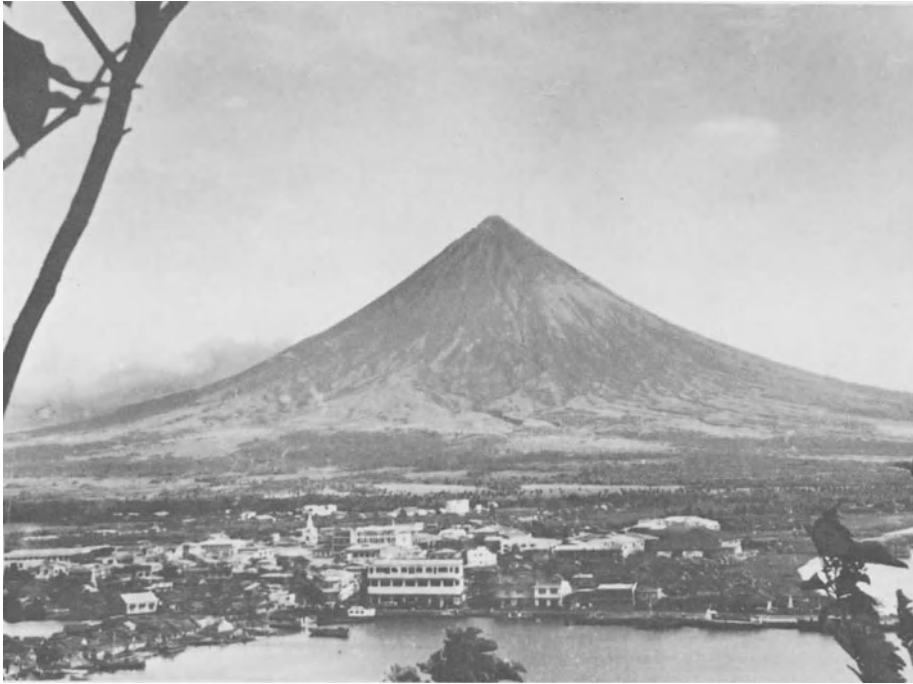
Plate 2.1. Mayon Volcano, Philippines, with the city of Legaspi in the foreground. Mayon is said to be the most symmetrical volcanic cone in the world, but it is potentially deadly. (Photo by Tommy's Studio, Legaspi)

Millions of people live in the shadow of active volcanoes and potential volcanic destruction (Plate 2.1), and will continue to live there. It has been estimated that during the last 500 years some 200,000 persons lost their lives as a result of the more than 500 active terrestrial volcanoes (Appendix C). Of these, some were killed directly by volcanic action, and others died of starvation caused by the destruction of food crops and animals. The figure does not include several tens of thousands killed by “tidal waves” (i.e. tsunamis; see Chapter 3) caused by volcanic eruptions. In 1902, on the Island of Martinique in the Lesser Antilles, in a matter of moments the volcano Mont Pelée almost wholly destroyed the city of St. Pierre, and some 30,000 persons lost their lives. If we are to avoid similar, and probably much worse, disasters in the future we must learn to give adequate warning of coming volcanic activity and to deal with the results of the activity.

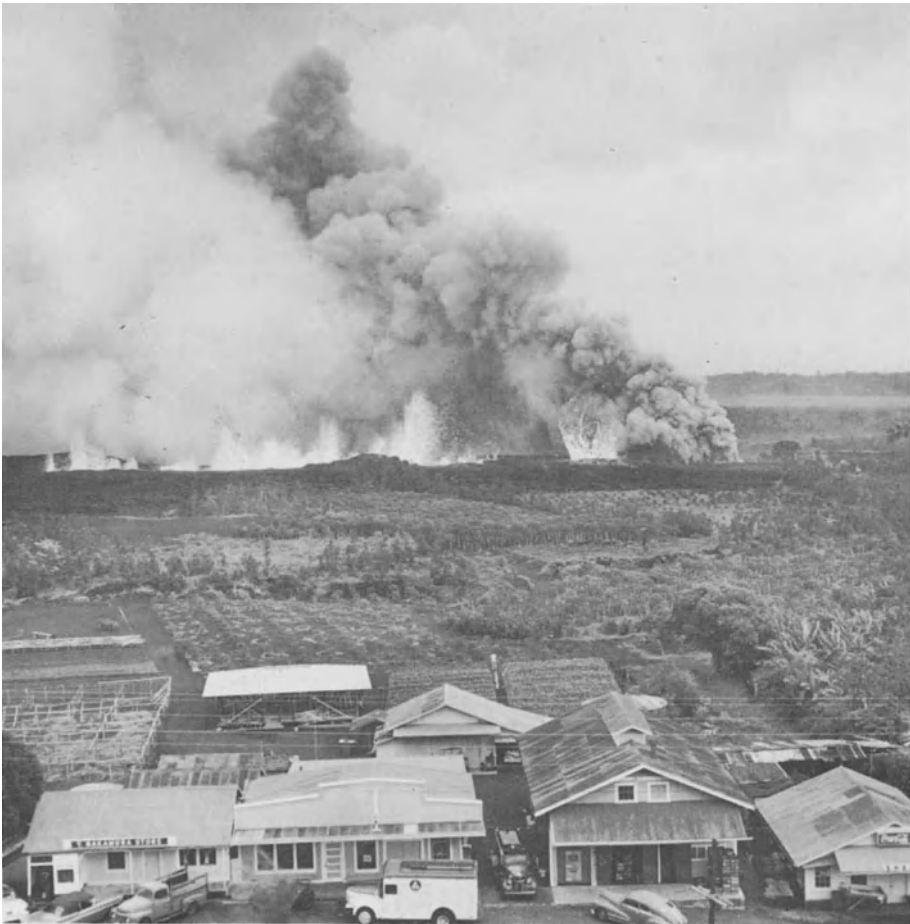
Plate 2.2. Lava fountains and flow along a fissure just outside of Kapoho village, Hawaii, January 14, 1960. The dark cloud rising on the right is ash-laden steam that resulted from the molten lava coming in contact with shallow ground water. Most of the village and about 400 hectares of agricultural land later were destroyed by the spreading lava. (Honolulu Advertiser photo by Gordon Morse)

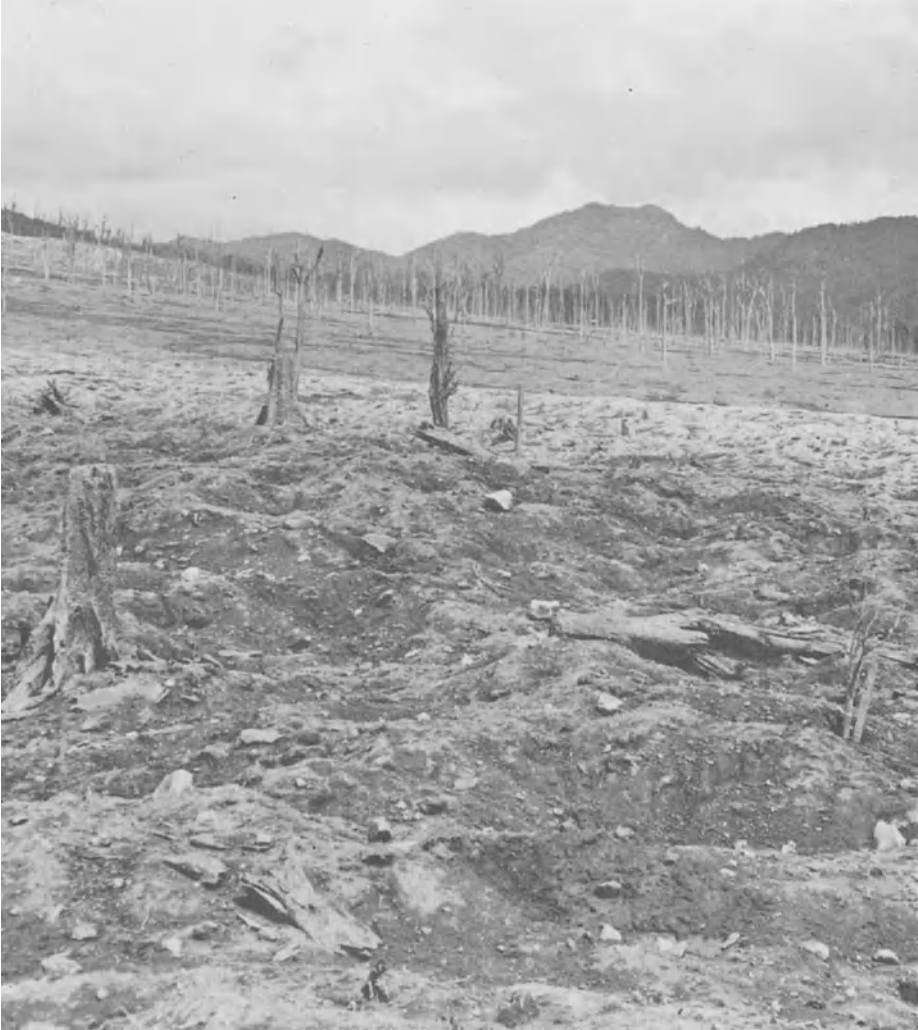
Plate 2.3. Region intensely cratered by bombs falling in soft ash, about 4 km west of the summit of Arenál Volcano, Costa Rica, during the eruption of 1968. Leaves and small branches have been stripped from the trees by the falling tephra. (Smithsonian Institution photo by William G. Melson)

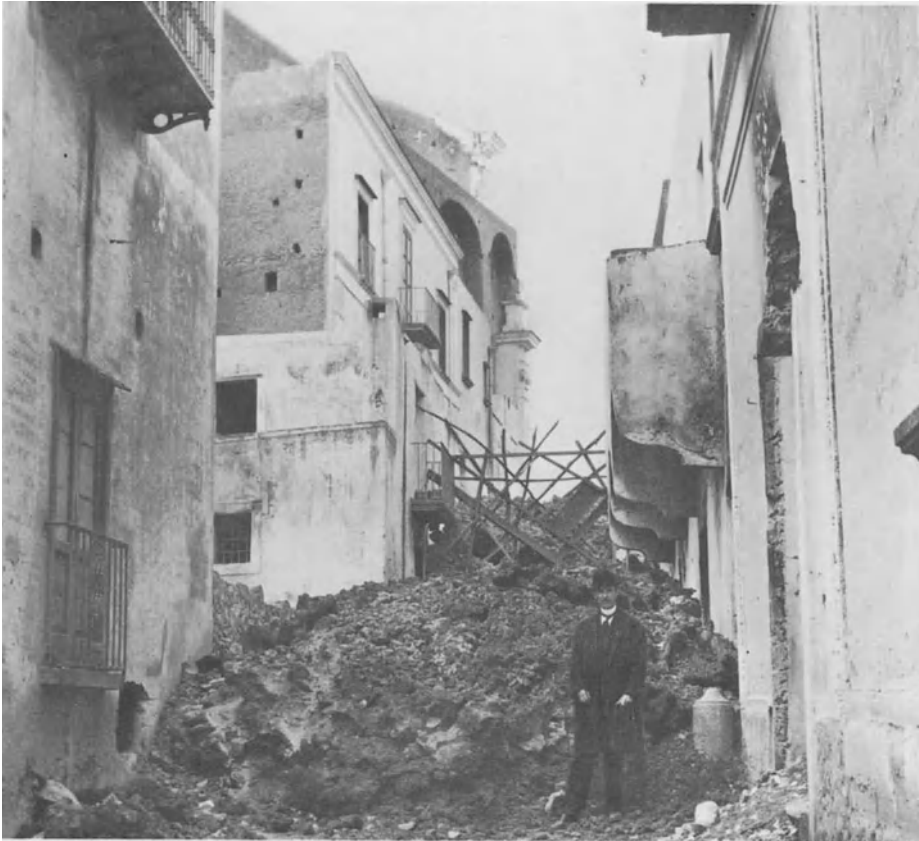
Plate 2.5. A lava flow in the streets of Bosco Trecase, during the eruption of Vesuvius in 1906. The thrust of the lava was not sufficient to cave in the masonry walls. (Photo by T.A. Jaggar)

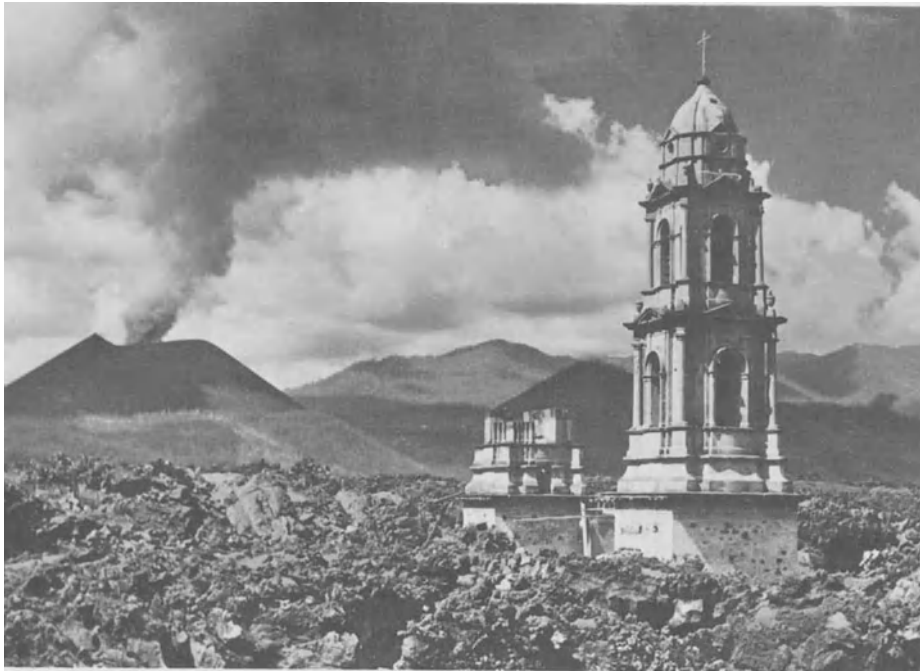
Plate 2.6. Towers of the cathedral of San Juan Parangaricutiro, Mexico, protruding from the rubbly surface of a block lava flow, July 1945. The building has been buried by lava to a level above the top of the nave. Paricutin Volcano, from which the flow issued, is visible in the left background. (Photo by Tad Nichols, Tucson, Arizona)

of Paricutin and most of San Juan Parangaricutiro, where the lava buried the old masonry church to the level of the top of the nave (Plate 2.6). Small amounts of it dribbled in through windows and doors, but the walls were not crushed, and the interior was left largely empty. Once again the small amount of thrust exerted on the walls by the lava is striking!

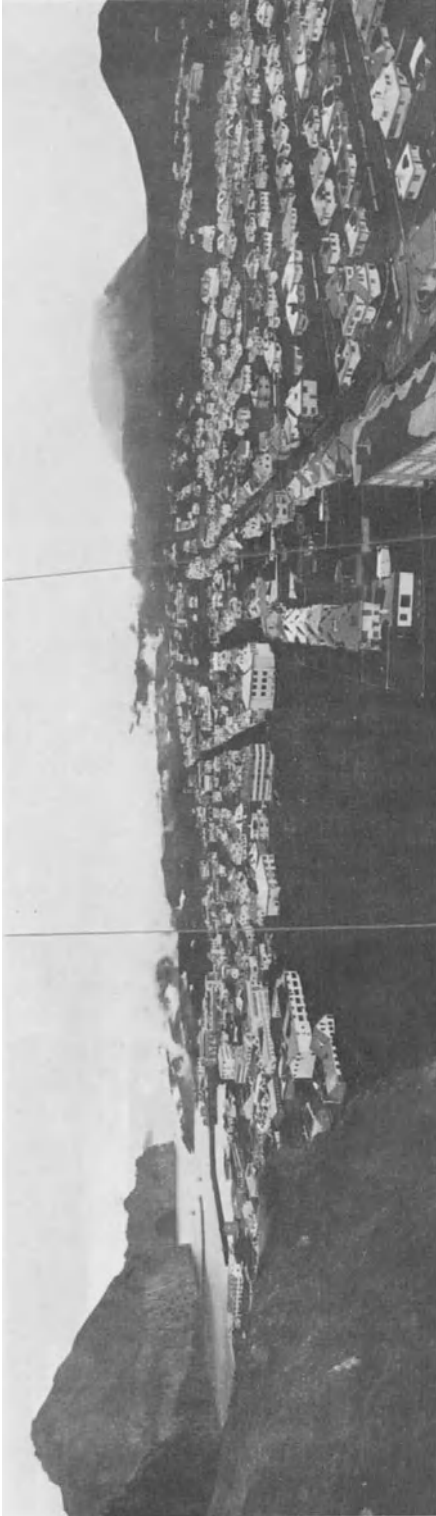
Plate 2.7. Lava flow burying the eastern portion of the town of Westmannaeyjar on Heimaey Island, Iceland, in early May, 1973. At the upper left, the lava is advancing into the harbor. At the far right is the prehistoric cinder cone Helgafell, and just to the left of it is the cone built by the eruption of 1973. A thick blanket of cinder and ash covers the part of the town nearer the camera, but much of it has already been removed from the roofs. (U.S. Geological Survey photo by James G. Moore)

The idea bore fruit during the eruption on Heimaey Island in 1973 (Plate 2.7). In a personal letter, Iceland's foremost volcanologist, Sigurdur Thorarinsson, writes: "...the method of pumping water on lava in order to slow up, stop or direct its movement has now, on the initiative and under the leadership of Th. Sigurgeirsson, Professor of Physics at the University of Iceland, been practised on a great scale (900 liters/second) and with remarkable success... The pumping has played an important role in the protection of the town of Westmannaeyjar."

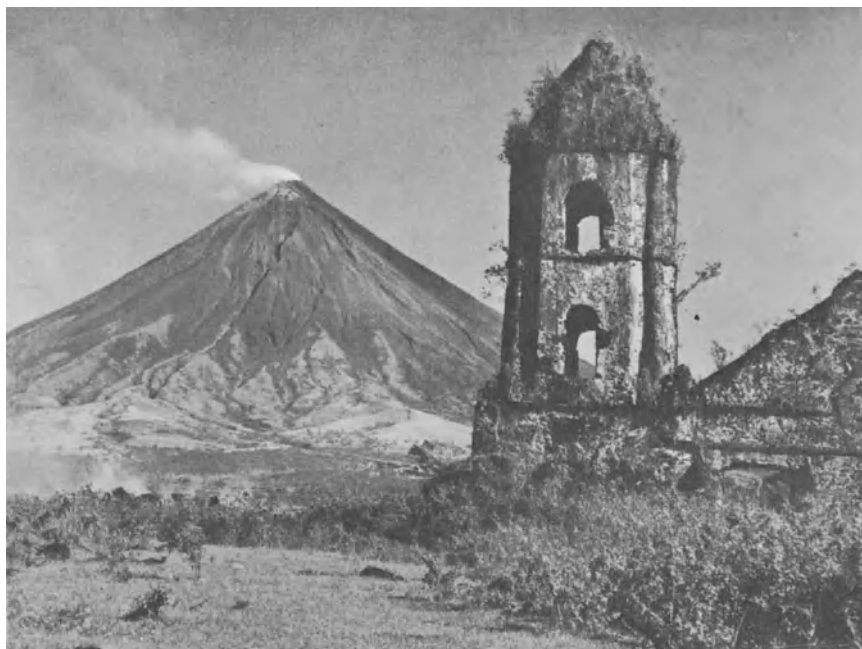
Plate 2.8. Church in Cagsaua, Philippines, buried to the top of the nave by a mudflow from Mayon Volcano (background) in 1814. It is reported that the people of the village had gathered in the church for refuge and all were killed

On the upper, steeper slopes of volcanic cones the effects of mudflows are largely erosive; but on the gentler slopes on the base of the cone and beyond the moving flow loses its velocity and starts to deposit material, and eventually the entire mass comes to rest as a sheet of debris commonly several meters in thickness. Whole farms and villages have been buried by these masses (Plate 2.8). Because of the high velocity—as much as 100 km an hour—that the flows

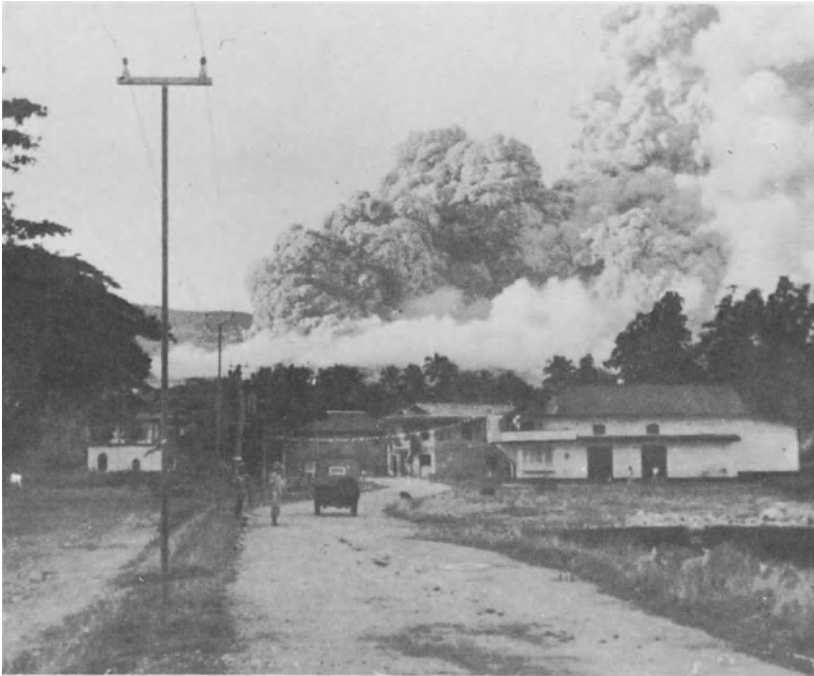
Plate 2.9. Glowing avalanche sweeping past the town of Mambajao (foreground) on the lower slope of Hibok-Hibok Volcano, Philippines, December 4, 1951. More than 500 persons were killed near Mambajao by glowing avalanches during this eruption. (Photo by Hibok-Hibok Studio, Mambajao)

The glowing avalanches of Hibok-Hibok Volcano, in the Philippines, in 1951 resembled those of Mt. Pelée. Starting in 1949, a dome grew in the crater and eventually extended through a low part of the crater rim onto the upper slope of the mountain. The glowing avalanche of December 4, 1951 (Plate 2.9), which took 500 lives in the outskirts of the town of Mambajao, resulted primarily from a low-angle blast directed outward at the base of the dome. However, another mechanism was also involved, both at Hibok-Hibok and at Mt. Pelée, where the explosions blasted away part of the dome, undermining the upper part, which then collapsed. This mechanism is the same as that which gives rise to the so-called Merapi type of glowing avalanche (Fig. 2.13C).

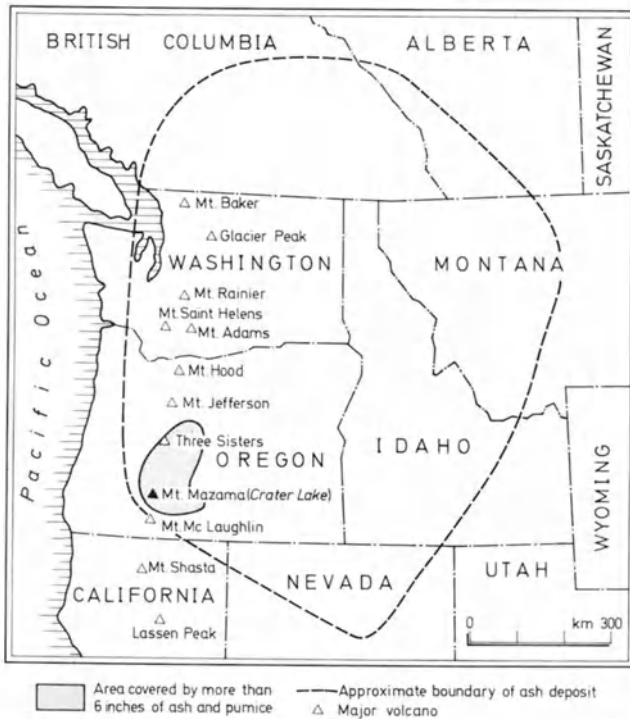
Fig. 2.16. Map showing the location of major volcanoes in the Cascade Range of Washington, Oregon, and California, and the distribution of ash from the great eruption of Mt. Mazama about 5,000 B.C. (After Williams and Goles, 1968)

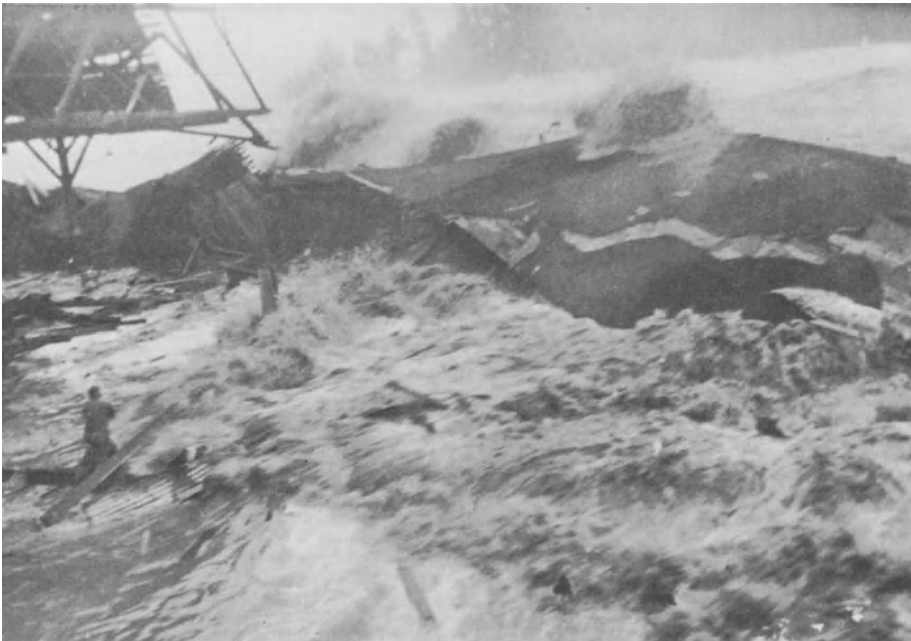
Plate 3.1. Seismic sea wave striking the pier at Hilo in the 1946 tsunami. Note the man in the path of the waves. He was never seen again. Photograph by an unknown seaman on the Brigham Victory. (Courtesy of R.L. Wiegel)

The waves bend as the portion in shallower water moves more slowly than that in deep water. Just as with light waves, such refraction can turn the waves around capes and coastal promontories and bring them inside an otherwise sheltered harbor. Certain coastal regions appear to have a topography which produces a *wave trap*, where the energy of a long stretch of the wave may be focused by the configuration of the sea floor or be reflected from a coastline to concentrate more or less at one place, for instance at Hilo, Hawaii (see Plate 3.1).

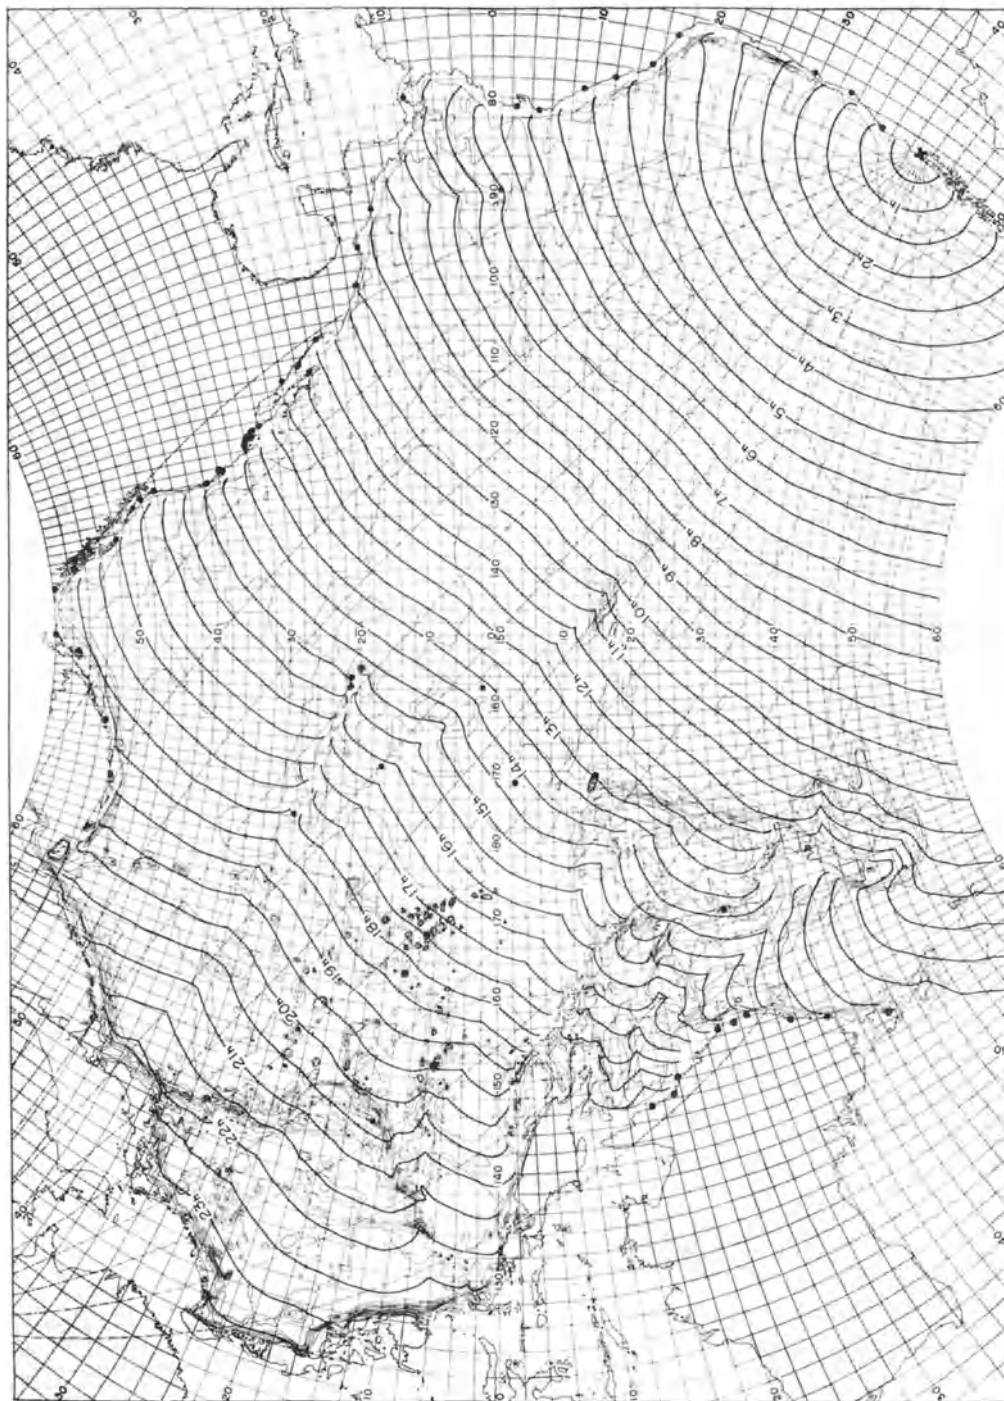
Fig. 3.1. Map of Pacific Ocean showing times of travel of the tsunami from the 1960 Chile earthquake. Bending of the wave fronts shows the effects of refraction from changes in ocean depth. Note the convergence of energy on to Japan. (Courtesy of Japan Meteorological Agency)

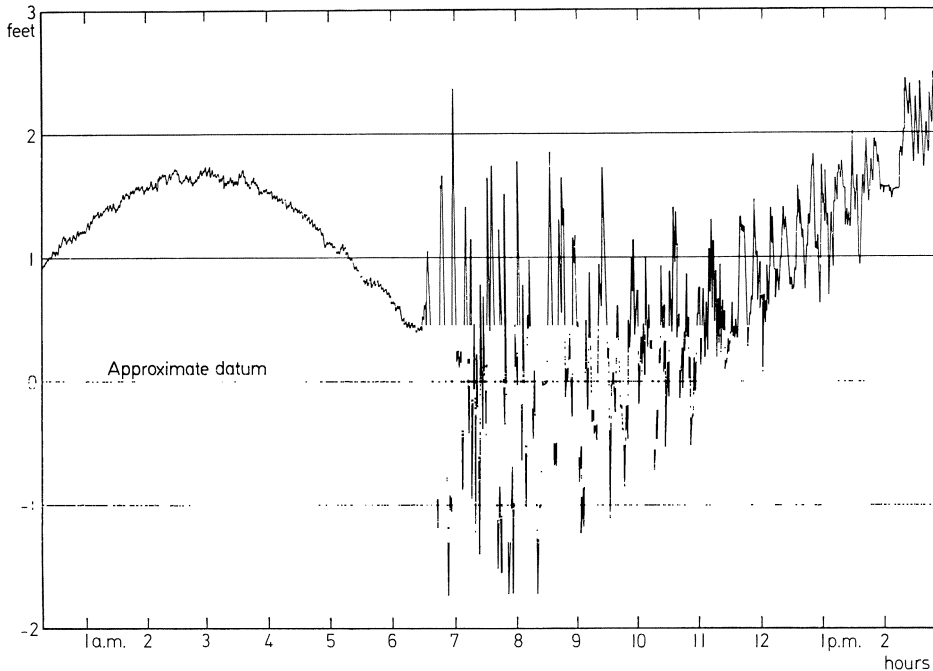
Fig. 3.2. Mareogram of the tsunami recorded by tide gage in Honolulu harbor on April 1, 1946. (Courtesy of USCGS)

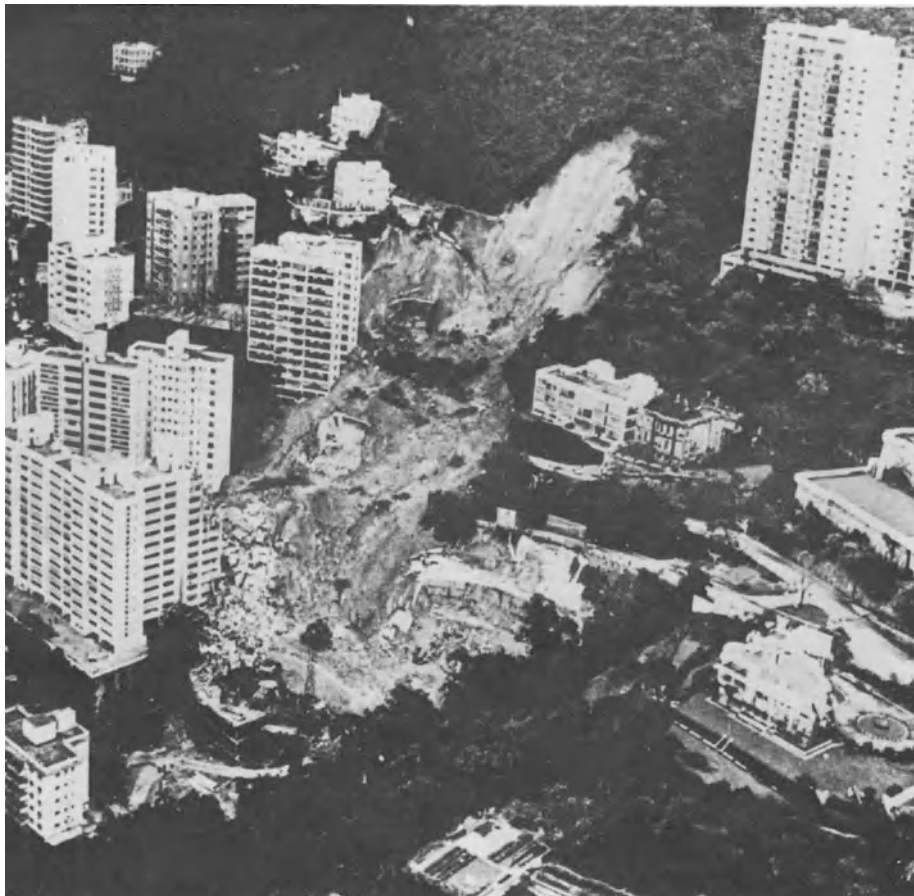
Plate 4.1. Hillside failure, Hong Kong. (Courtesy of Fugro, Inc., Long Beach)

tions of towns and cities, communication systems, and large structures including dams and bridges (see Plate 4.1). Because of the variety of materials, mechanisms and rates involved, the ordering of aspects of ground movement is a challenge to the naturally-inclined classifier; in consequence, many schemes for classification have been adopted, and a few of their more important aspects are discussed below.

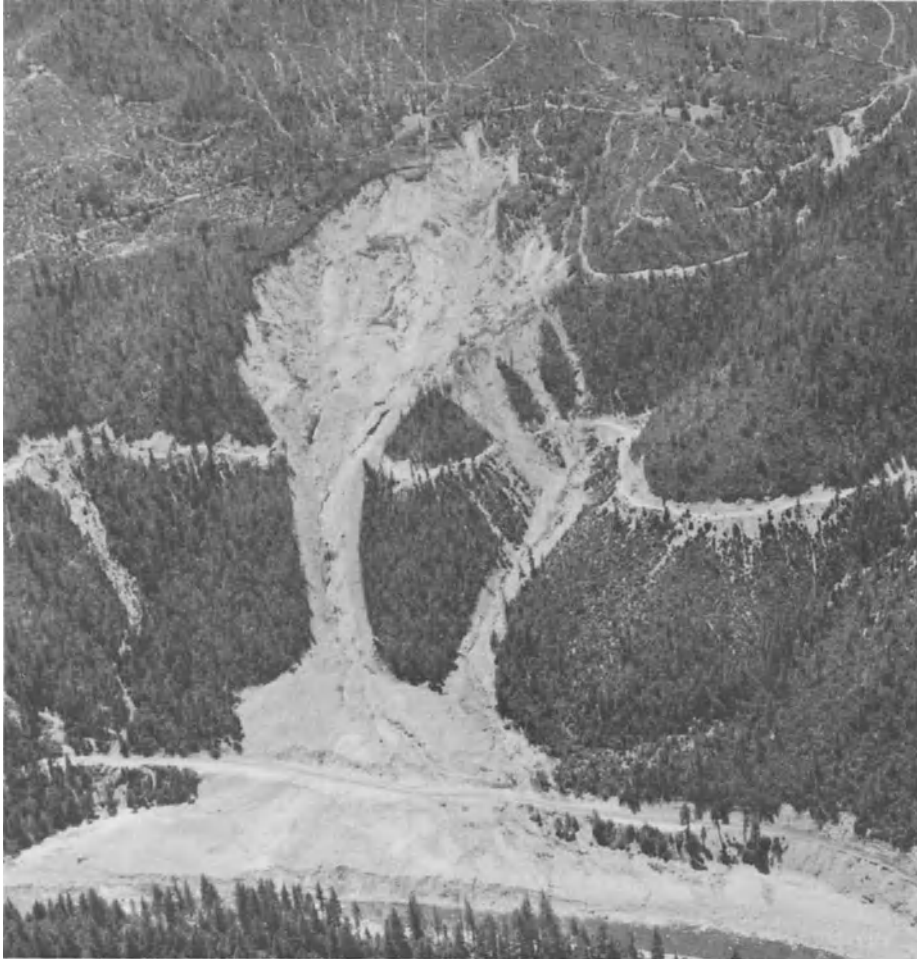
Plate 4.2. Landslide in forested slope, Oregon. (Courtesy of Brann Johnson, Calif. Institute of Technology)
