# Geological Hazards

Revised, 2nd Edition

Earthquakes – Tsunamis – Volcanoes  
Avalanches – Landslides – Floods

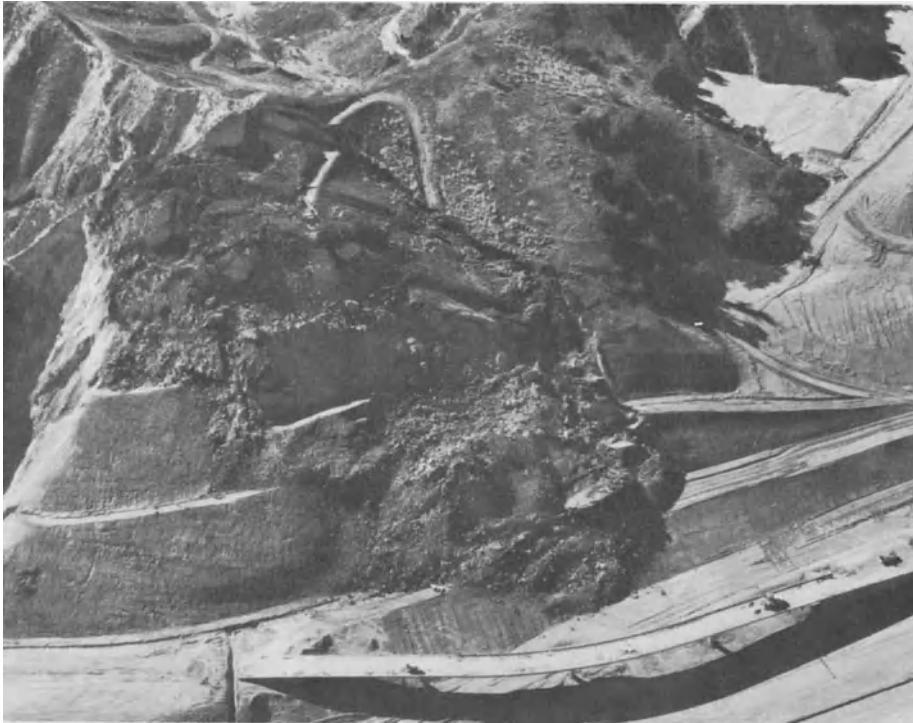
Plate 4.3. Landslide in cut slope during San Fernando earthquake of February 9, 1971. (Courtesy of State of Calif. Dept. of Public Works)

the result that a feature commonly associated with earthquakes is landsliding on a scale depending upon the topography in the epicentral area. During and following the 1971 San Fernando, California earthquake thousands of landslides and rockfalls occurred in the San Gabriel mountains and caused a prominent dust cloud over the strongly shaken area for days (see Plate 4.3).

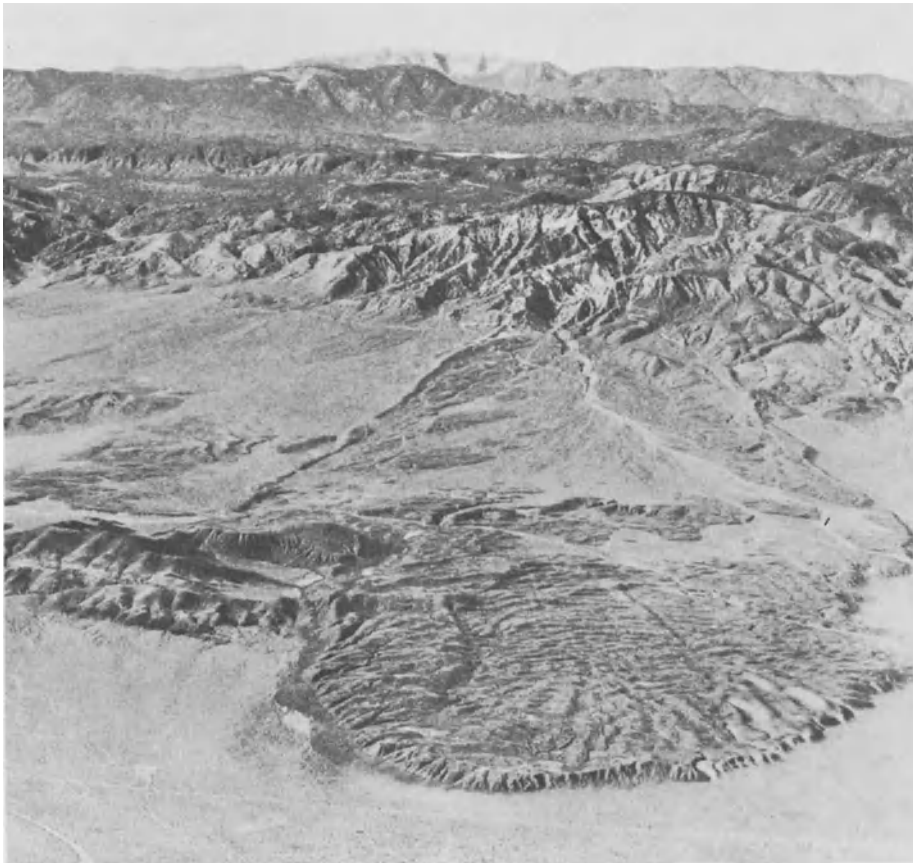
Plate 4.4. Blackhawk landslide, Mojave desert, California. (From R.L. Shreve thesis, Calif. Institute of Technology)

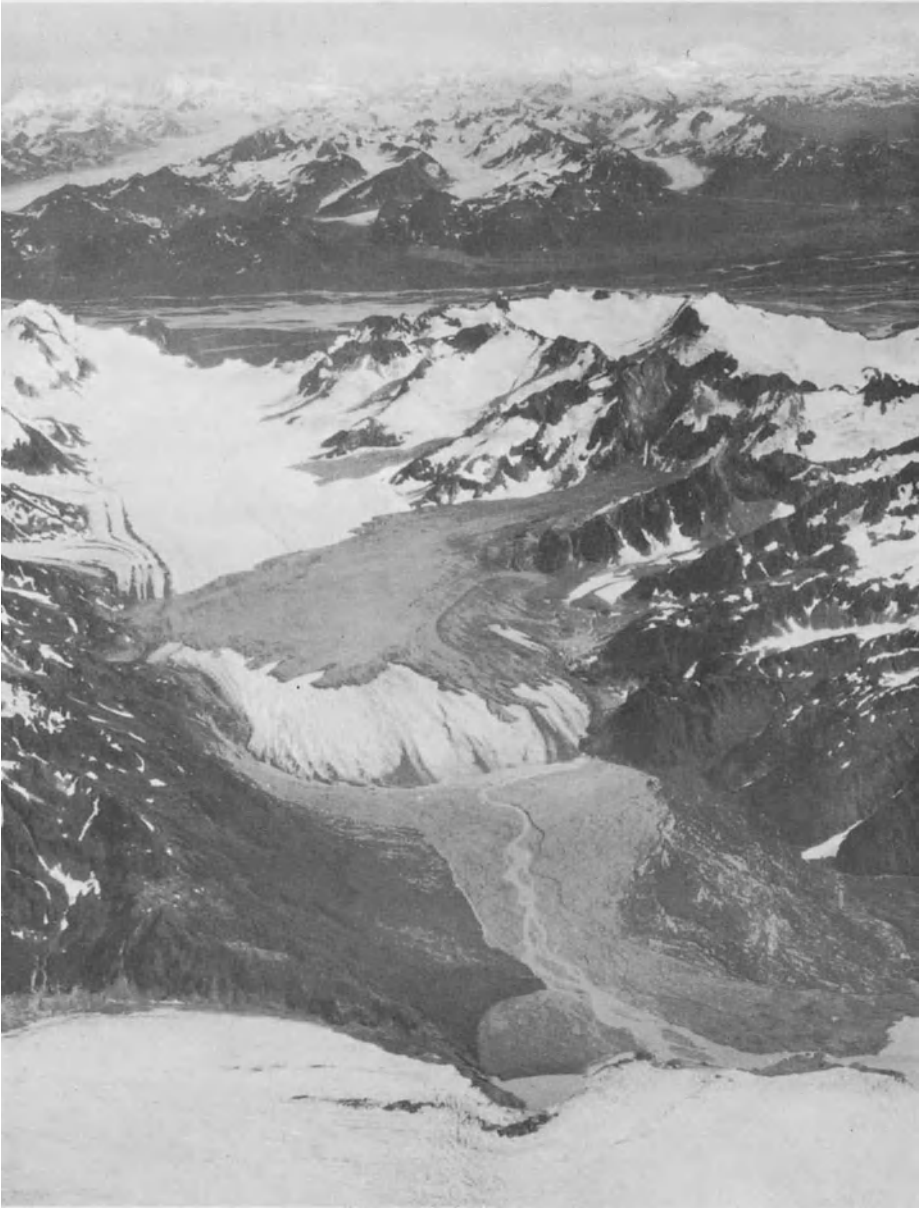
Plate 4.5. Sherman Glacier landslide, Alaska. (Courtesy of Austin Post, USGS)

The great March, 1964 earthquake in Alaska (see Section 1.1) caused a number of landslides to develop, two of which will be discussed in this chapter. The first of these is the Sherman Glacier slide, illustrated in Plate 4.5. At a distance of approximately 140 km from the epicenter there is a region of high mountains and glacier-filled valleys. One of the mountains, now called Shatter Peak, was shaken so violently that a portion of rock near the crest of the mountain broke off. As the material fell down the mountainside, it disintegrated and the mass attained substantial velocities. In this case, there was no narrow canyon to contain

the material arriving at the base of the mountain; instead a glacier extended several kilometers across the valley. The landslide arrived at and traversed the glacier, spreading as it went, to form eventually a flat, lobe-shaped deposit several kilometers in lateral dimensions and only a few meters in thickness. The volume of material involved was about 23,000,000 cubic m.

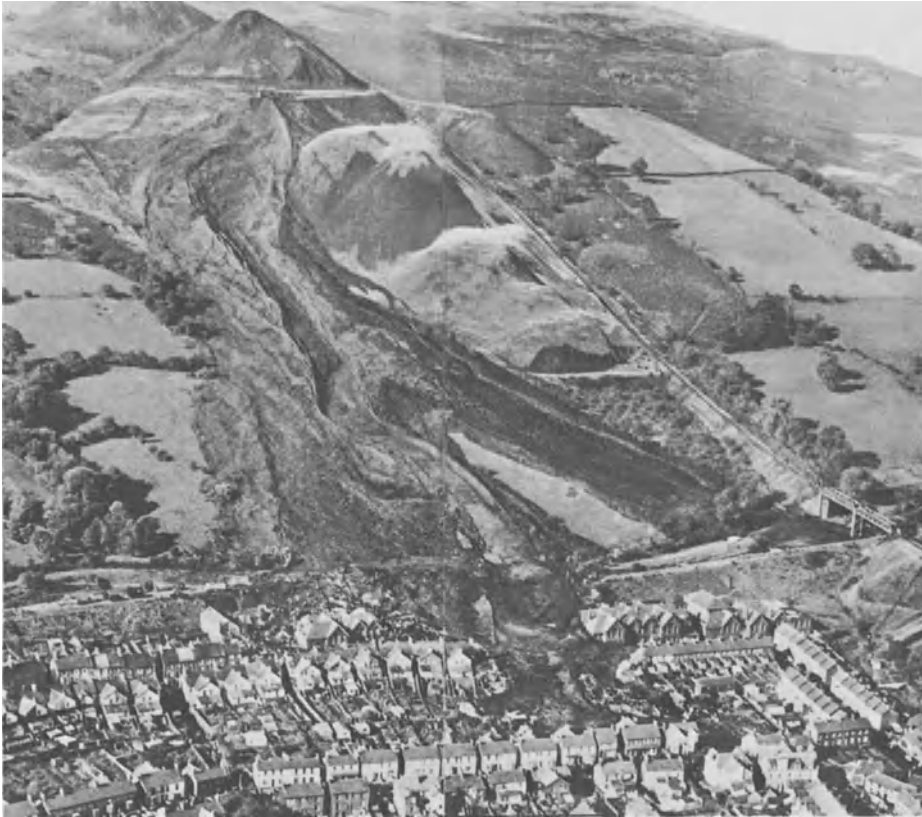
Plate 4.6. Failure of Tip No. 7, Aberfan, Wales. (Report of the Tribunal of Inquiry, HMSO)

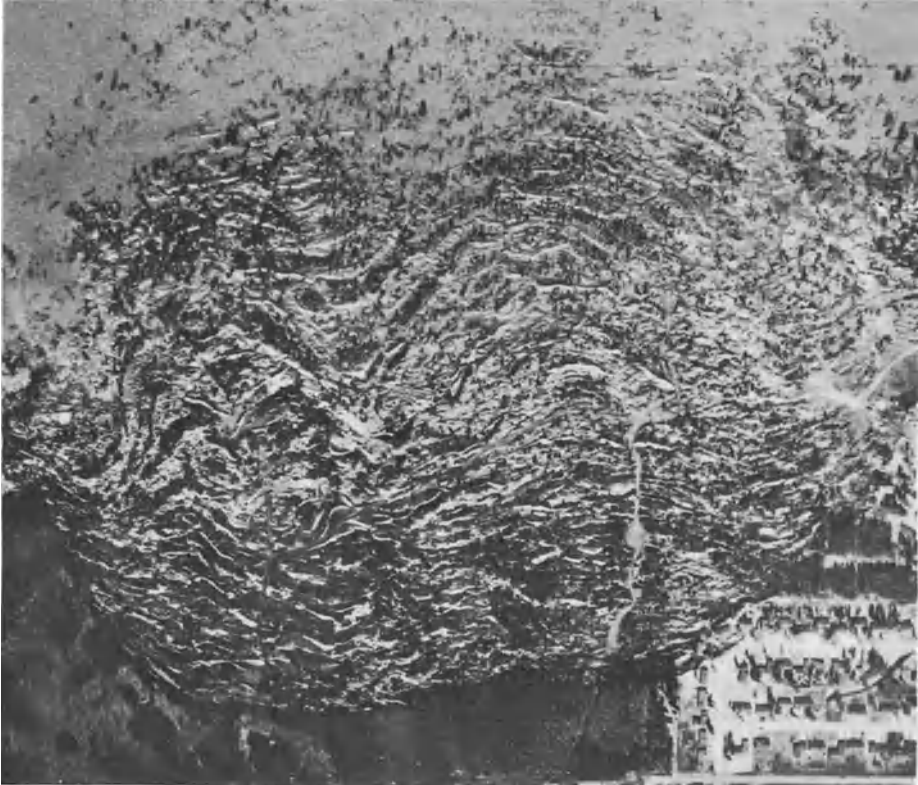
Plate 4.7. Aerial photo of Turnagain Heights landslide, Alaska. For scale, see houses in bottom right corner

consequence of the oscillations, was a cause of the landslides. In a single landslide during this earthquake, an area approximately 2.5 km along the coast broke as much as 0.5 km inland and slid towards the ocean, causing great damage in the residential area of Turnagain Heights, where some of the sliding blocks moved as much as 300 m. Eyewitness accounts, though not entirely consistent, indicate that the sliding movement started some time after the initiation of earthquake movements and continued after the earthquake stopped. Other landslides occurred along the bluffs near Anchorage causing disruption of utilities and commercial structures, although the movements were not as great as at Turnagain Heights (see Plate 4.7).

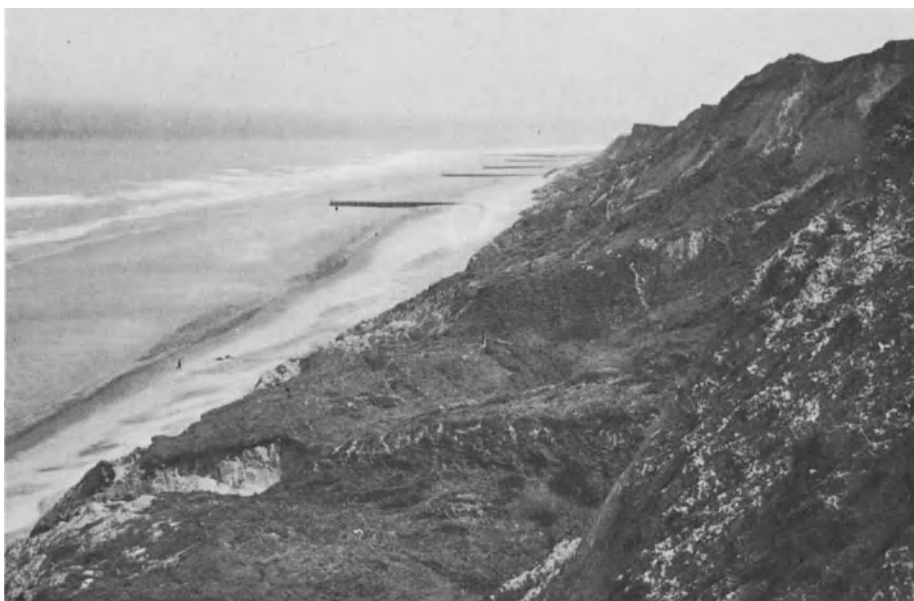
Plate 4.9. Landslides and coastal erosion, East Anglian coast, England. (Photo by R.F. Scott)

Such coastal modifications by the sea are, of course, common around the world but have, perhaps, been best studied in Great Britain because of the importance of the loss of land to the crowded island. The cliffs along the south and east coasts of England (see Plate 4.9) have been eroding for many hundreds

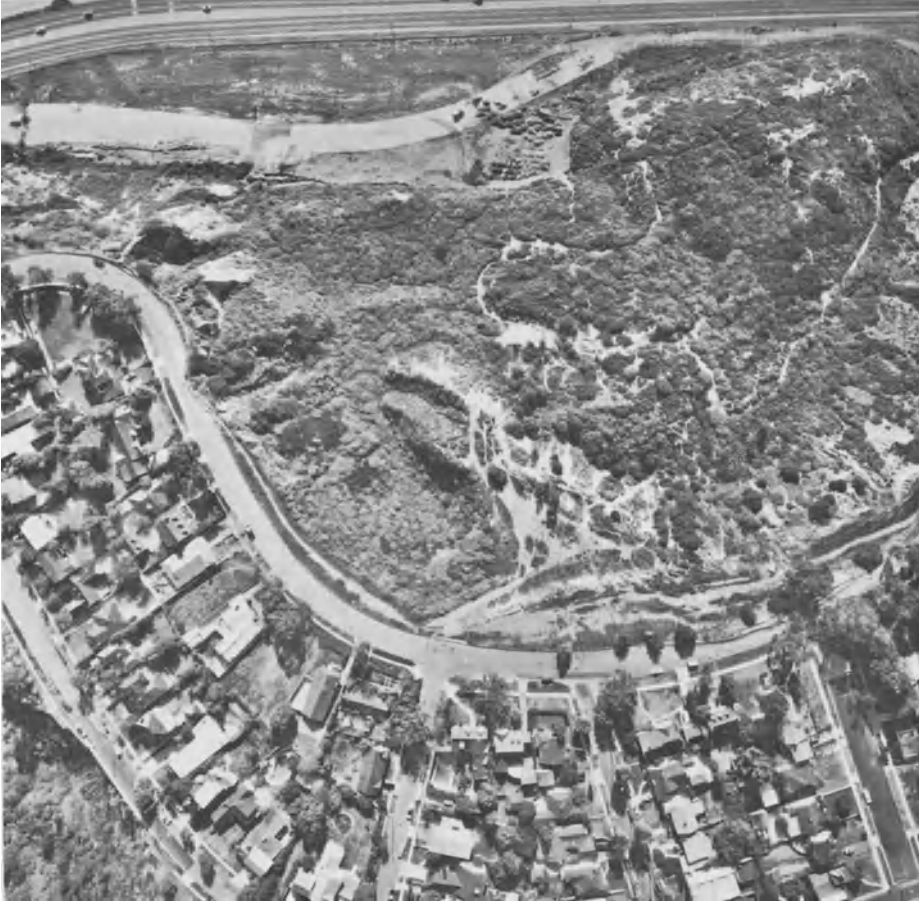
Plate 4.10. Ancient, periodically reactivated landslide, coastal highway 101, Santa Monica, Calif. The slide occupies the semi-circular area above the curving perimeter road. The relocated highway runs along the top of the photograph. (Courtesy of Pafford and Associates, Los Angeles, Calif.)

Along the coast near Santa Monica, in particular, the cliffs are 20 to 50 m high, consist of weak siltstones and sandstones and are plentifully fissured and faulted. A major landslide occurred there in 1959 and was large enough to require the relocation of a major highway which formerly ran along the toe of the slope. Landslides in this area have caused the highway alignment to be changed a number of times (see Plate 4.10). Generally speaking, in these regions the major slides are preceded by creeping movements which are frequently detected because of the density of population and structures in the area.

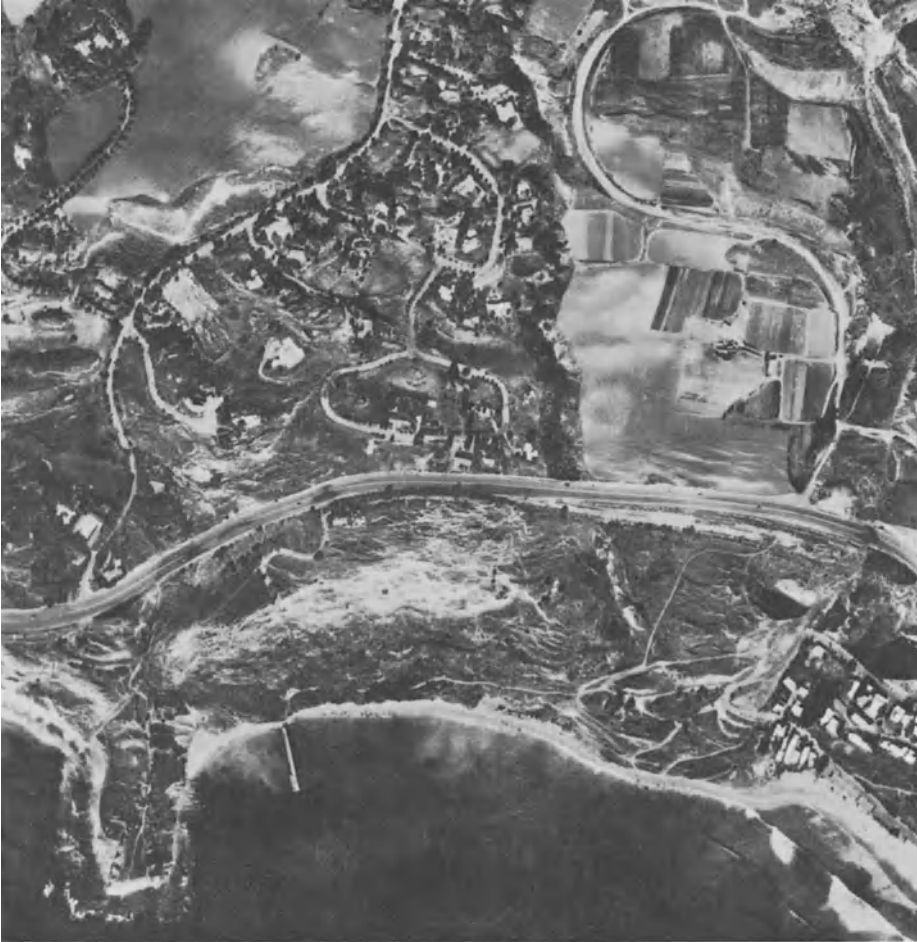
Plate 4.11. Portuguese Bend landslide, Los Angeles, Calif. The right edge of the slide lies to the left of the houses in the bottom right corner. On the left the slide is split by the rocky promontory. The rumpled topography including houses, occupying the middle of the picture is the surface of the slide mass. (Courtesy of Metrex Aerial Surveys, Los Angeles, Calif.)

In 1956 a large portion of the area, about a kilometer square, began to move on a slope of only  $6.5^\circ$ , and within a few months the movement had reached approximately 20 m. A scarp formed at the top of the sliding area, and intermediate fissures and fractures developed in the sliding mass itself (see Plate 4.11). The highway running across the base of the slide material had to be relocated a number of times in following years as the slide continued to move, houses located on and at the edges of the slide area were racked, and, in the majority of cases, had to be removed. To the present time (April 1974) the slide has moved a maximum distance of approximately 70 m, and is still

moving at a rate of about 3 m per year. The cause of the landslide was the subject of a legal debate between Los Angeles County and a homeowners' association. It is estimated that \$10,000,000 worth of property damage was done by the moving mass.

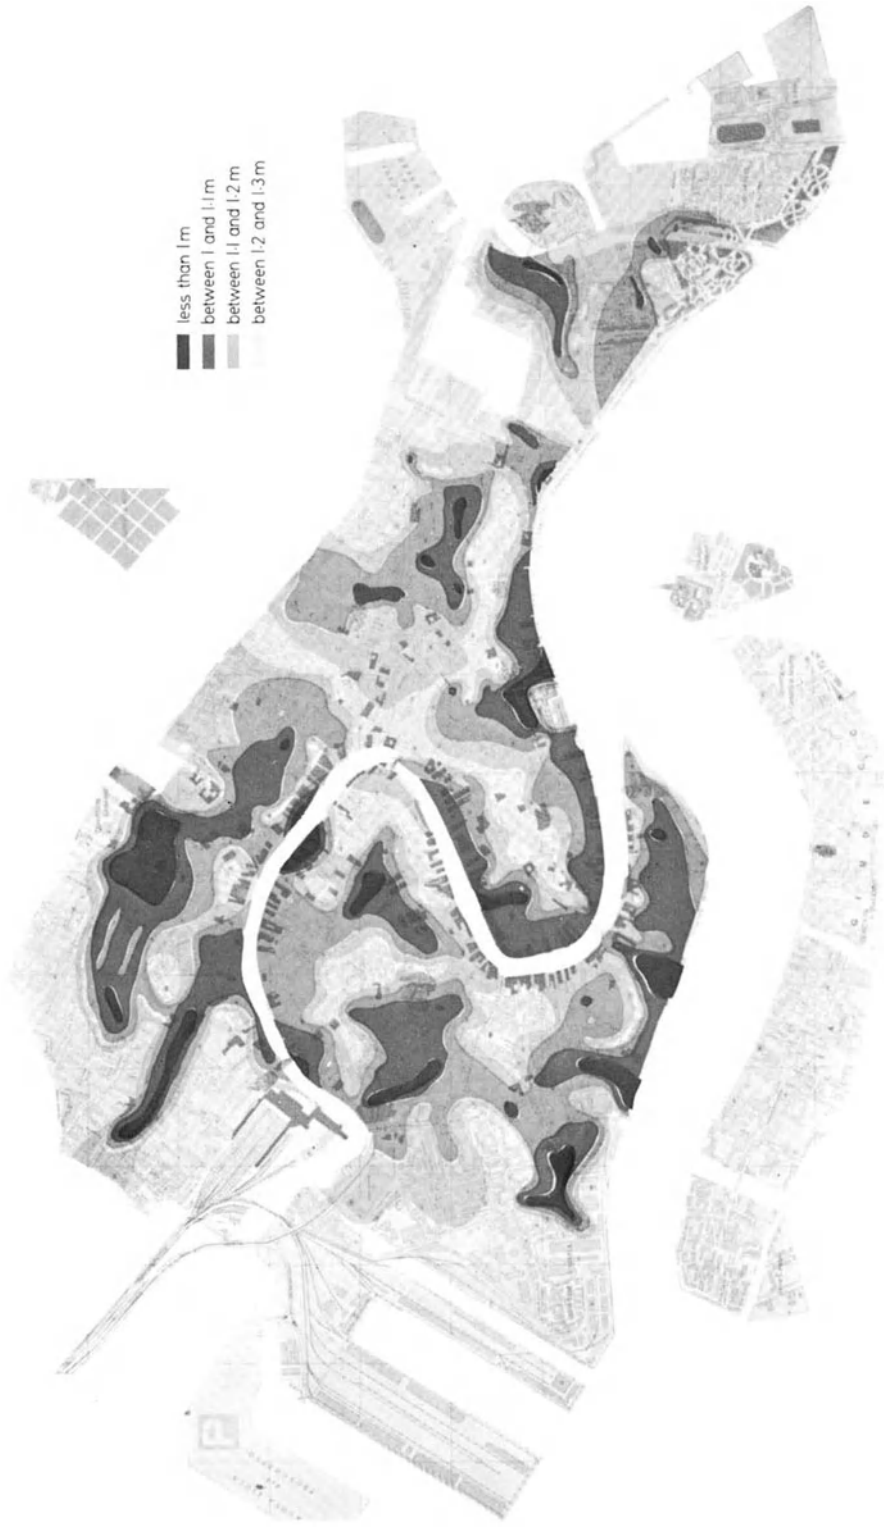
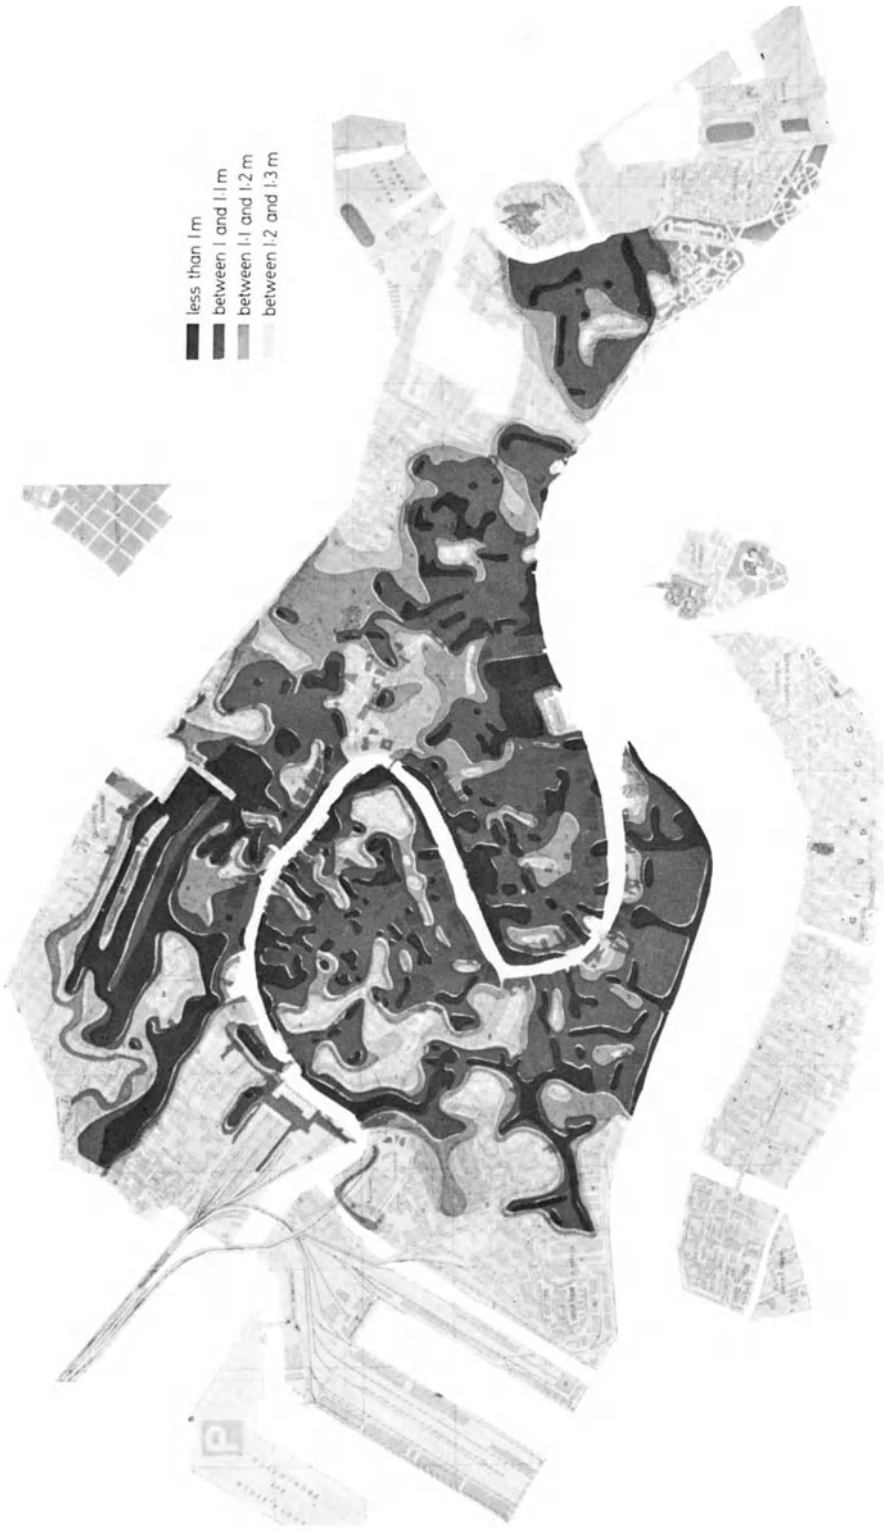
Plate 5.2a and b over. Areas of Venice inundated by different sea levels: (a) 1908, (b) 1961 (from P. Colombo, *Rivista Italiana di Geotecnica* 6, 7–30, March 1972)

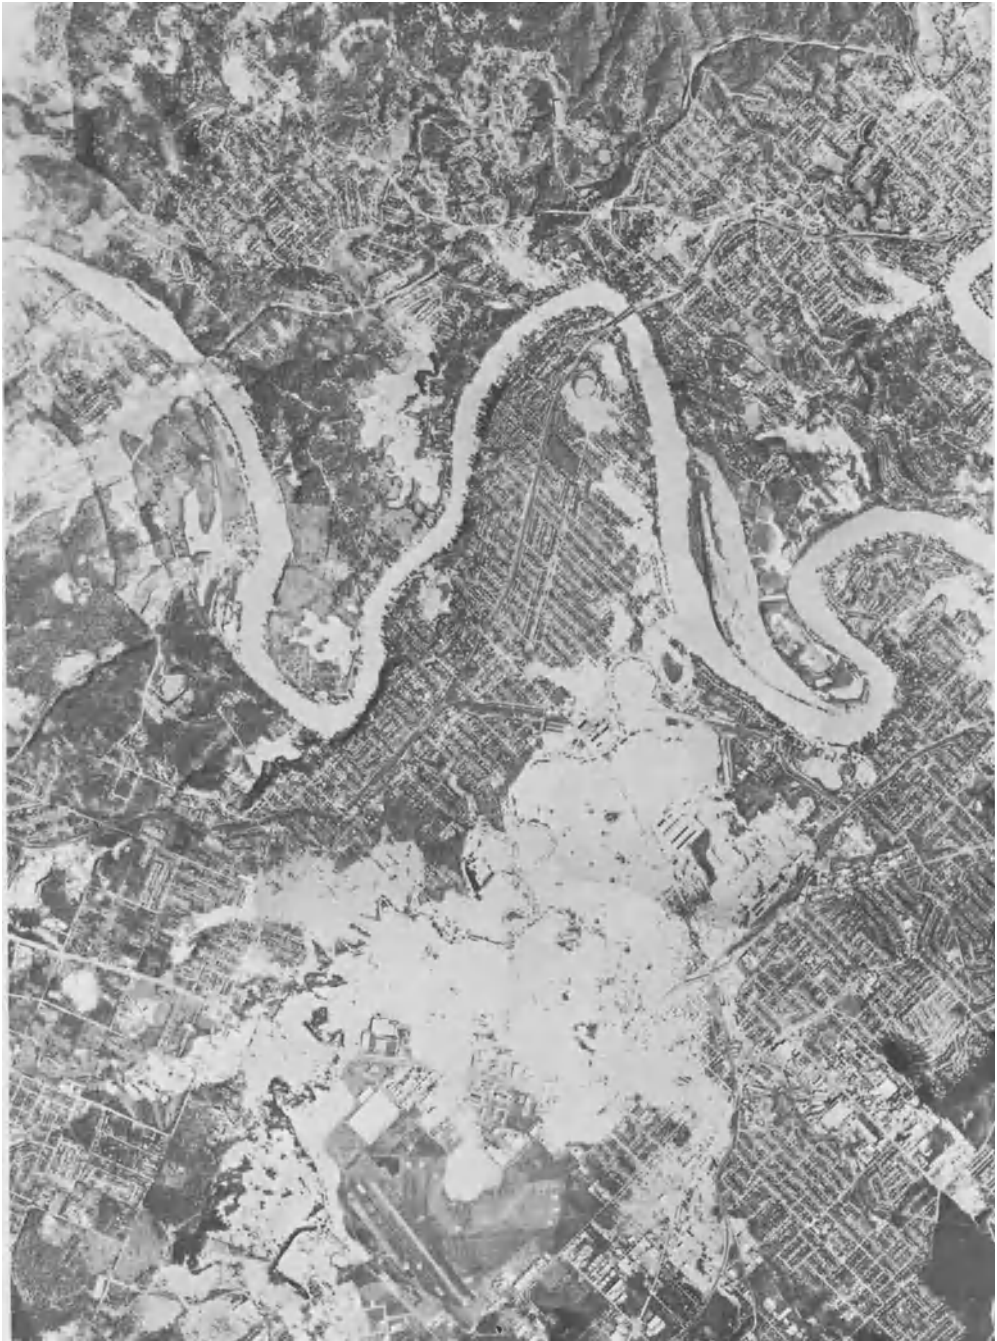
Plate 7.1. An aerial photograph showing the inundation of Brisbane, Queensland, Australia in the great flood of January 1974. (Photo mosaic by Mapmakers Pty. Ltd., Brisbane, Australia)

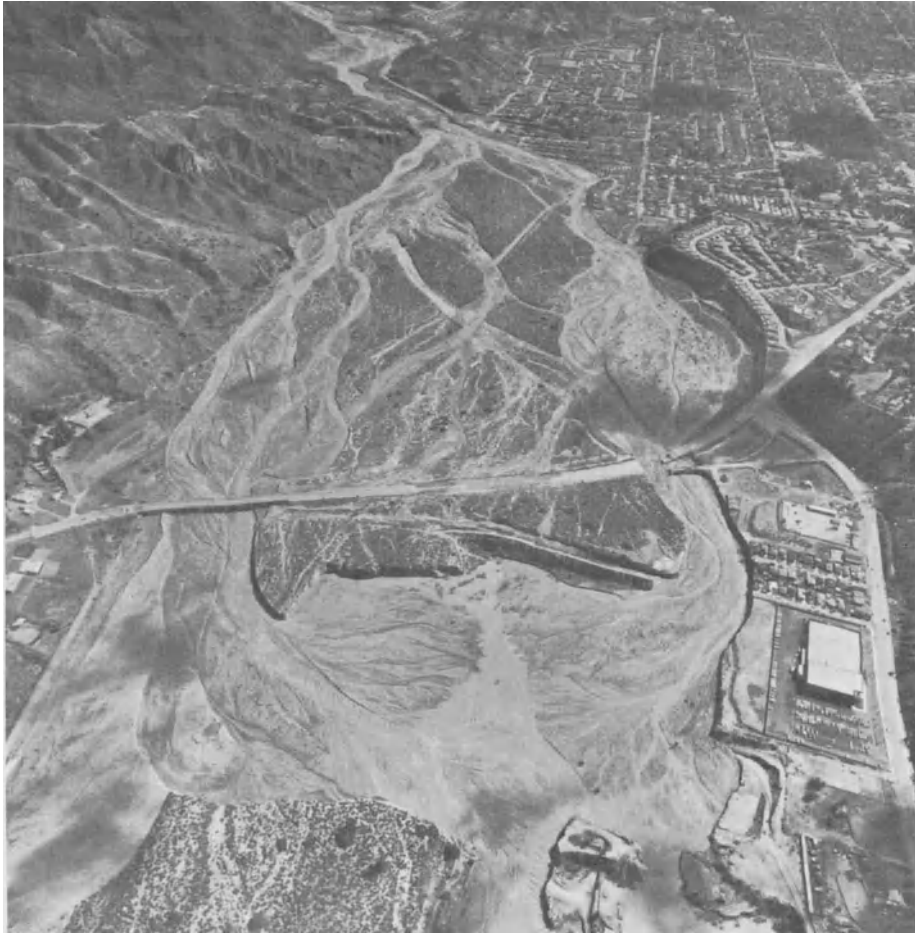
Plate 7.4. In Los Angeles County, California, February 1969, flood flows came roaring out of Big Tujunga Canyon, destroying Foothill Boulevard Bridge (upper bridge) and Wentworth Peace Bridge. (Courtesy of Los Angeles County Flood Control District)

Stream channels are constantly moving laterally, as shown by maps of stream courses made years ago and compared with present channel locations (see Plate 7.4). Erosion picks up some material and deposits it in a different location. The rise and fall of river level with an increase or decrease in velocity encourages the cutting action.

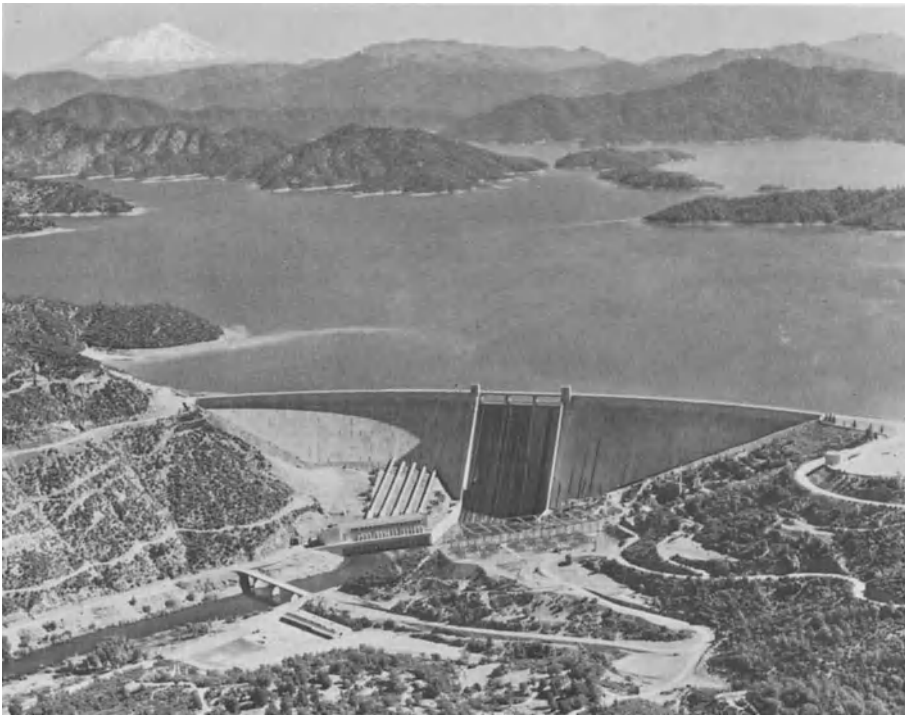
Plate 7.5. The Shasta dam and multi-purpose reservoir on the Sacramento River in northern California. The snow-capped volcanic peak of Mt. Shasta is in the background to the north. (Courtesy of U.S. Bureau of Reclamation)

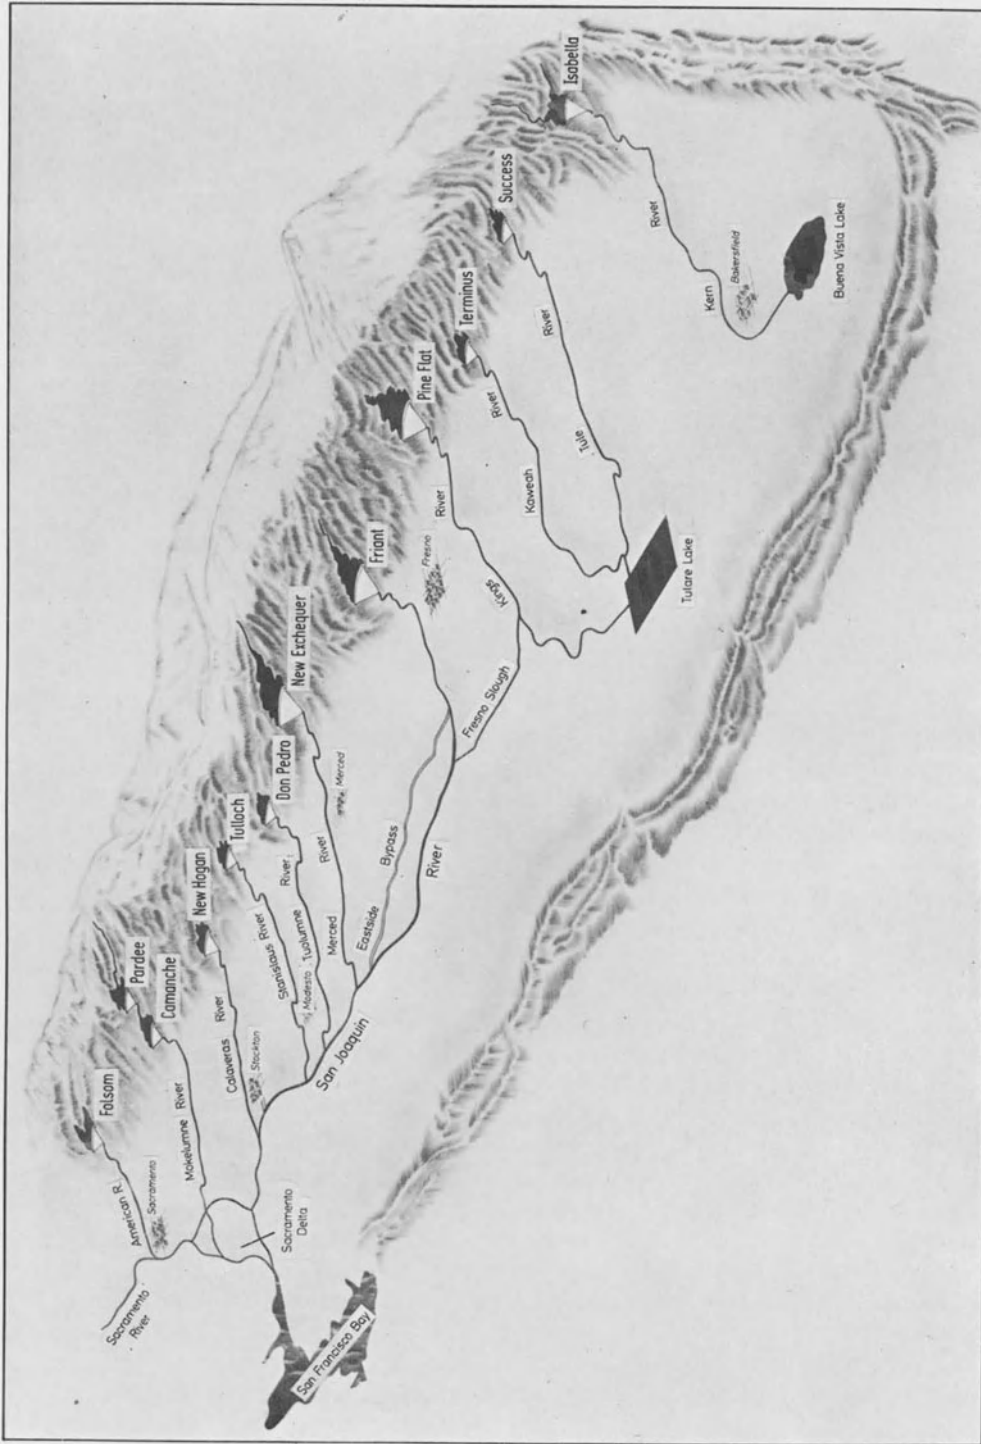
Plate 7.6. Flood control system for the San Joaquin valley, California, using dams in the foothills of the Sierra Nevada and holding lakes in the valley. (Courtesy of California Department of Water Resources)

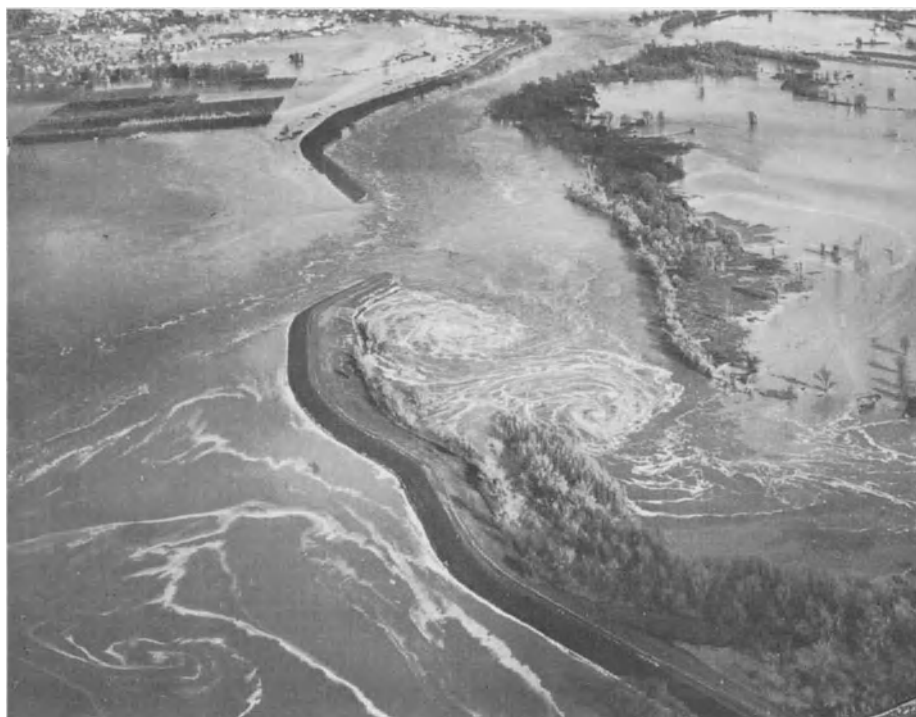
Plate 7.7. The breach of a levee on the Feather River, California near Yuba City, during the floods of December 1955. (Courtesy of California Department of Water Resources)

property along the channel, as shown in Plate 7.7, would be much aware that more material on a natural levee would increase the carrying capacity of the channel and prevent it from overflowing on his land. Dikes were originally constructed by groups of farmers seeking to defend their plots against floods. Along the Yellow River in China are dikes that have been in existence since 603 B.C. In 69 A.D., during the Han Dynasty, the individual works were standardized and unified into a flood control system. In most regions subject to river floods the same pattern is followed today, and as land development expands, the need for a unified flood control system becomes more evident.

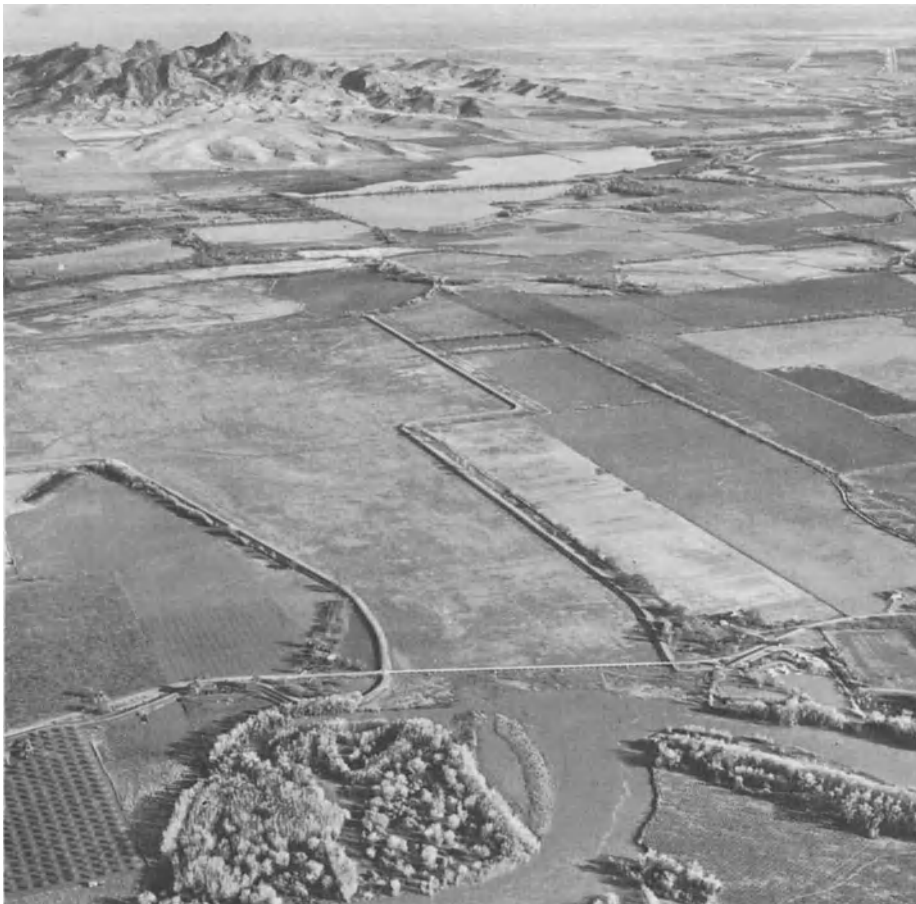
Plate 7.8a. In the foreground can be seen the Colusa by-pass weir in California. In the background to the east are the Sutter volcanic buttes. In the dry summer, the land used for storage is cultivated. (Courtesy of California Department of Water Resources)

A solution to this common problem in many countries nowadays is to provide by-passes that can be farmed during summer months, but carry the flood flows during the winter rainy season (see Plates 7.8a and 7.8b). The main levees, built closely adjacent to the river contain fixed elevation overflow weirs over which higher floods flow into the by-passes. The weirs act as safety valves, limiting the level in the river.

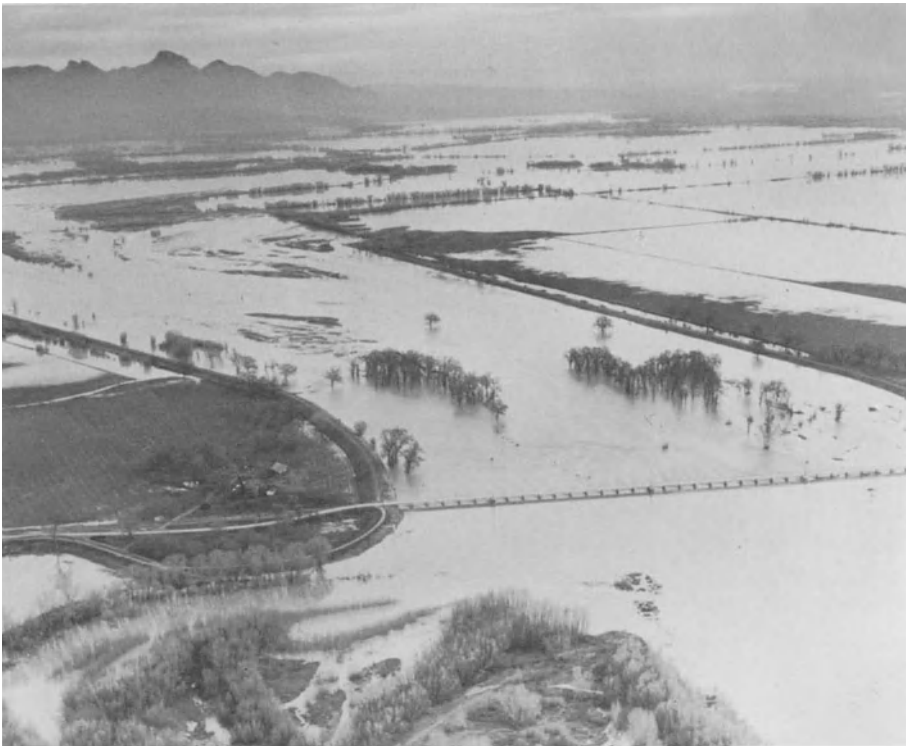
Plate 7.8b. A similar view of the Colusa by-pass weir to that above showing water passing over it into storage during high water on the Sacramento River. (Courtesy of California Department of Water Resources)

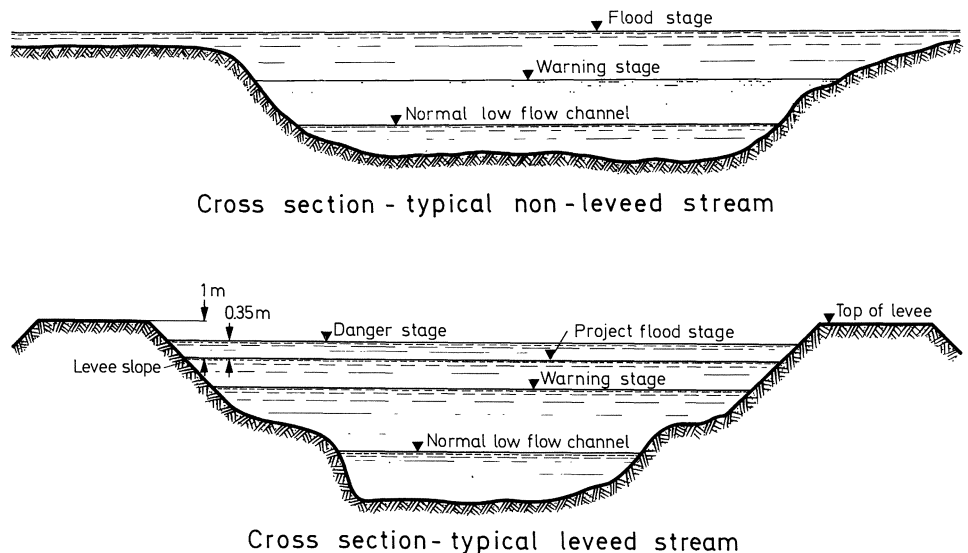
Fig. 7.8. Flood warning stages for non-leveed (above) and leveed (below) streams

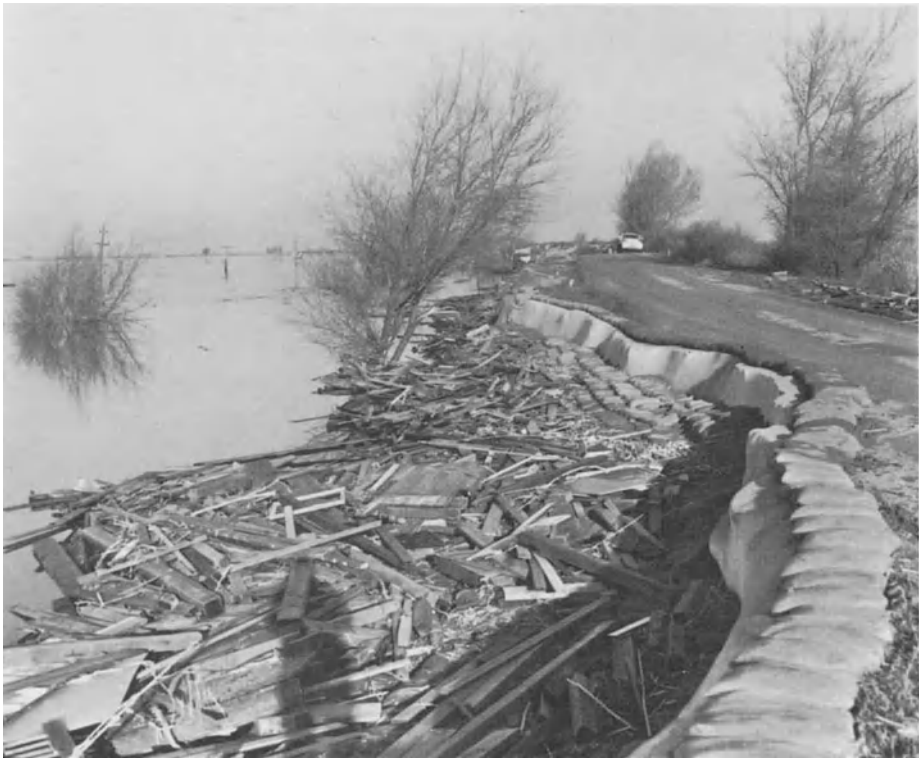
Plate 7.9. Repair work to levee along Sherman Island, California. (Courtesy of California Department of Water Resources)

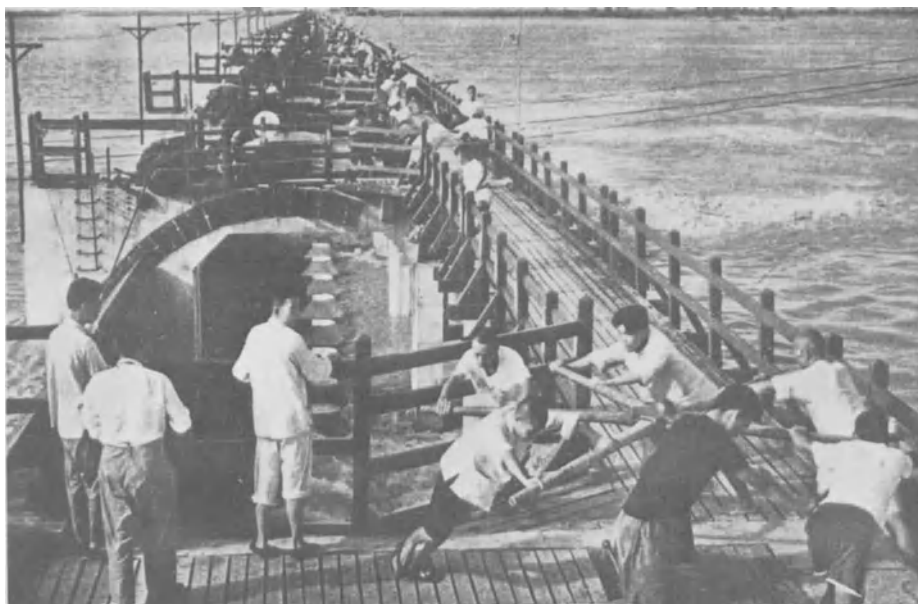
Plate 7.10. Adjustment of water flow through a weir at Tai Ping Kou flood detention basin on the Yangtze River, China (from R. Alley, 1956)

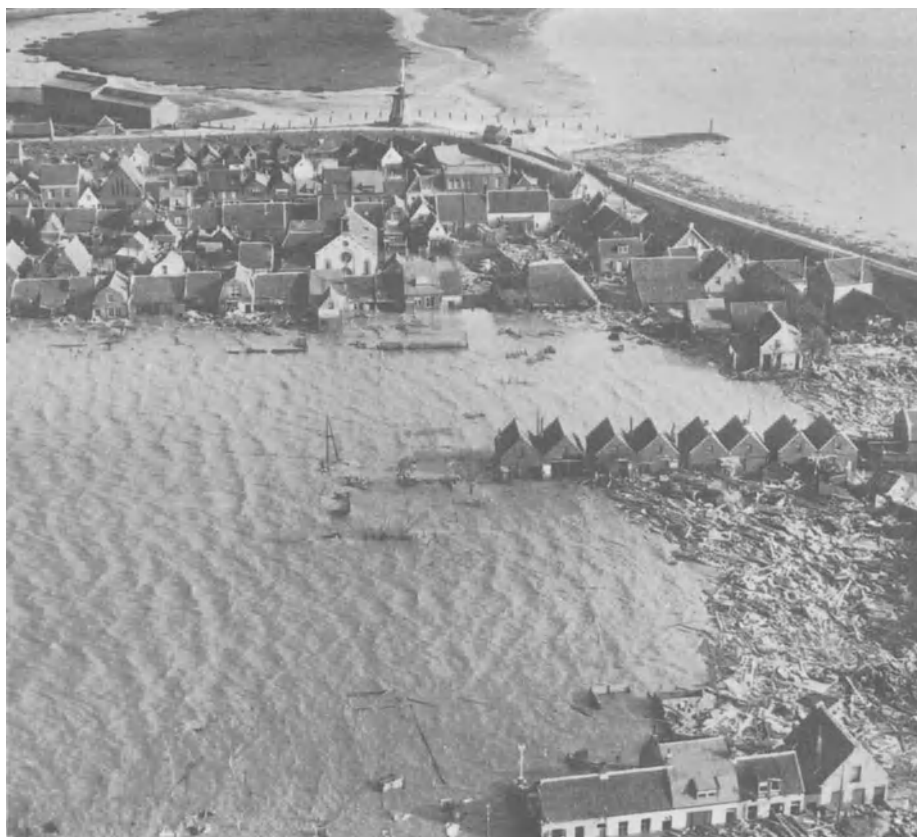
Plate 7.11. Desolation across flooded polder at St. Philipsland in Zeeland Province in the great January 1953 inundation from the North Sea. (Courtesy of Aero-Photo "Nederland" and Netherlands Consulate General, San Francisco)

An area over 100,000 hectares went under salt water, which is about 6 per cent of the cultivated land of the Netherlands. The population of the flooded area was 660,000 out of the total population of 10,500,000, the number of persons killed was 1,490. Livestock losses were heavy, 60,000 animals drowning. About 5,000 houses were destroyed or badly damaged in Zeeland (see Plate 7.11) and thousands in other places. The total damage was put conservatively at \$250,000,000, about double the damage done by floods in England during the same storms.

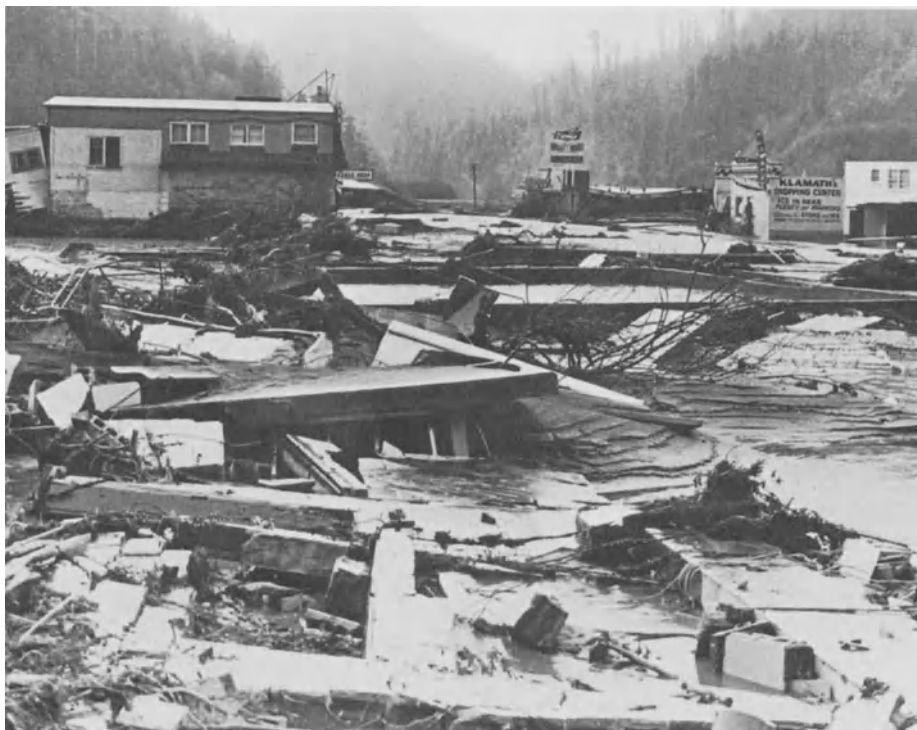
Plate 7.12. The town of Klamath on the Klamath River in northern California was destroyed in a flash flood in 1964. The town has since been relocated at a higher elevation. (Photo by Eureka Newspapers Inc.)

Typically, localized damage in such flash floods is severe (see Plate 7.12). There were 237 deaths and a total of 2,932 persons were injured, with flood damage of over \$120,000,000. 750 homes were destroyed and between 1,000 and 2,000 cars were damaged by the flood, over 6,500 families suffering losses. There were at that time no flood protection works of significance in the flooded area, but Rapid City is now planning to spend almost \$50,000,000 to acquire private property on the Rapid Creek flood plain and convert it to a park.

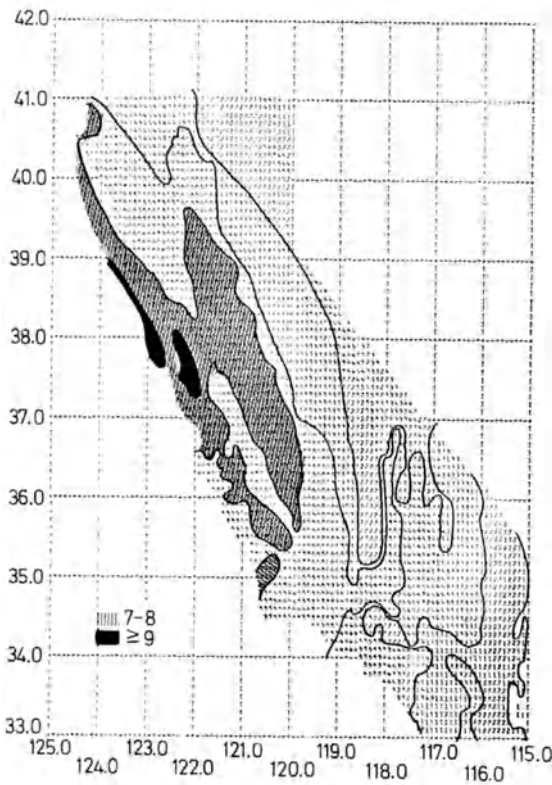
Fig. 8.2. Computer-simulated isoseismal pattern for the 1906 San Francisco earthquake. Numbers representing MM intensities are printed out by computer. Compare the isoseismals with the observed intensity mapped in Figure 1.3. (Courtesy of D.G. Friedman in "Geologic Hazards and Public Problems", 1969)

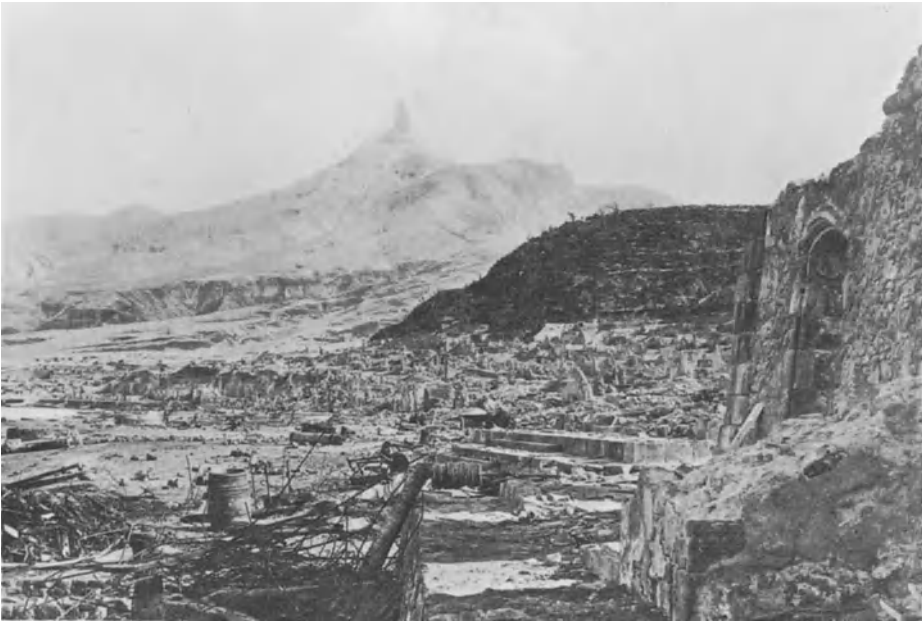
Plate 8.1. The ruins of St. Pierre, Martinique, in May 1903. The city was destroyed by the glowing avalanche of May 8, 1902. Mont Pelée, with the dome and great spine at the summit, are visible in the background. (Photo by Alfred Lacroix, courtesy of Masson et Cie, Paris)

Geological hazard is a strong function of the population density; St. Pierre Martinique had a population of 30,000 concentrated in a small area when it was destroyed in 1902 (see Plate 8.1). What is more, it is essential in establishing priorities for prediction and control to have also reliable estimates of the population growth rate.
