# Geological Hazards

Revised, 2nd Edition

Earthquakes – Tsunamis – Volcanoes  
Avalanches – Landslides – Floods

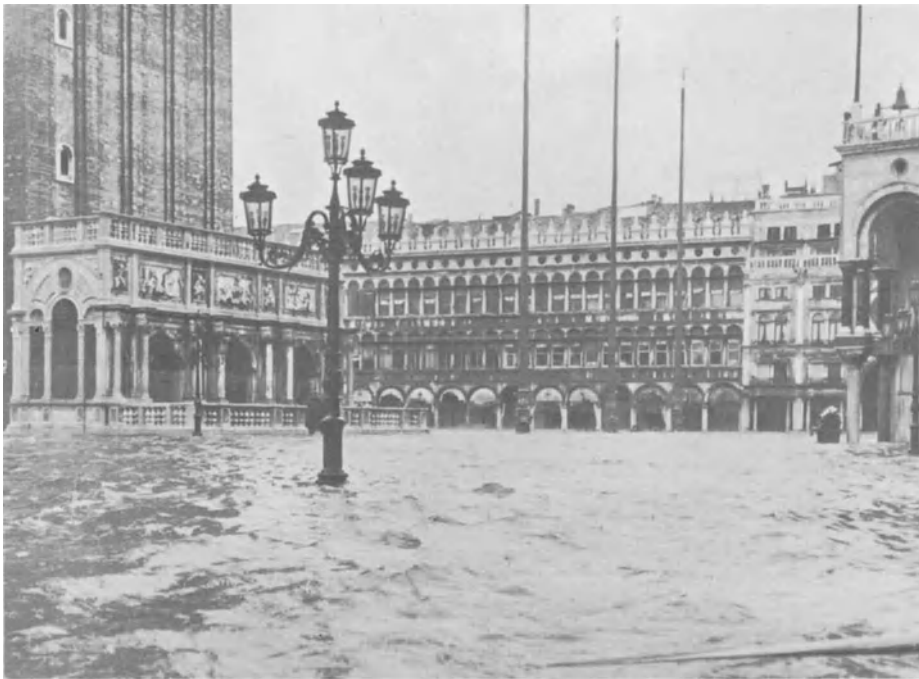
Plate 8.2. The Piazza San Marco at Venice has become a continuation of the Lagoon at periods of high tides and particular weather conditions. Photo taken on November 4, 1966. (Courtesy of Jürgen Schulz)

In recent decades, inundation of the city has become more and more common (see Plate 8.2), for which there appear to be several reasons. First, there is an almost imperceptible rise in the sea level itself, about 1<sup>1</sup>/<sub>2</sub> mm a year. Secondly, the ground has subsided due to the pumping of underground fresh water in industrial areas along the coast, perhaps another 5 to 10 mm change in level a year (see discussion in Chapter 5). Thirdly, protective sea walls have been neglected; and fourthly, the storage area of the lagoon has been reduced by diked fishing grounds and filled land areas (see Fig. 7.11).
